Eyezon Home Inspectors 470 Golden Gate Blvd. W. Naples, FL 34120

# Real Estate Inspection Report

1234 Anywhere Street Naples, FL 34444

Page 1 of 36 Eyezon HI Sample Home Inspection E020202M

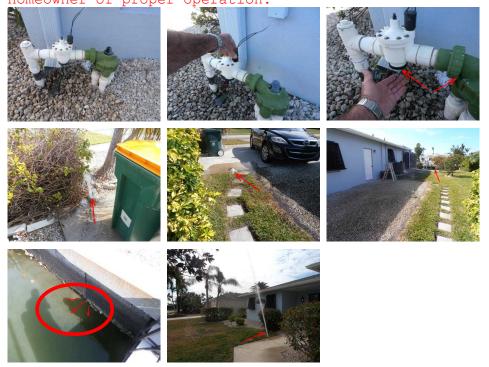
9. Defective Lawn Sprinklers: Front and back yard Irrigation timer is missing. Several broken sprinkler heads noted, Sprinkler zone manifold is leaking, under ground sprinkler lines appear to be damaged, water is coming out through seawall. I recommend a qualified irrigation contractor go through entire sprinkler system, evaluate and or repair all that is needed for proper operational , adjust/repair all sprinkler heads, and educate the new homeowner of proper operation.

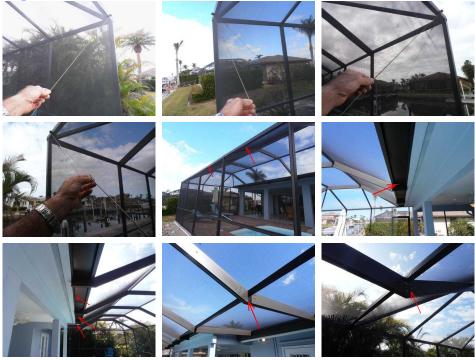
- 16. Marginal
- Pool Enclosure: Screen cage Screen cage tension cables are extremely loose and should be tightened. These cables help prevent the cage from moving in windy or bad weather conditions, when this happens it also stretches the screens causing them to become loose or torn. Screens are loose and spline is pulled loose or missing in a few areas and is in need of repair/replacement, cage has pulled loose from structure in a few areas and trusses have been re-screwed. These issues are a result of hurricane Irma. Recommend a licensed Aluminum pool enclosure contractor further evaluate ALL hurricane damage and estimate costs to repair or replace any issues if needed before close.
