# Dtex Battery Compartments

By Sven Stau

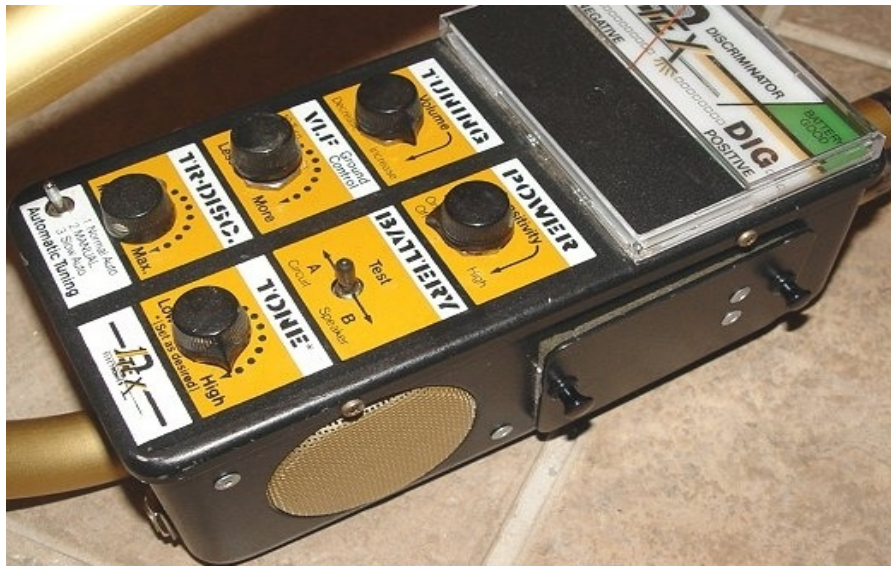
Some of the older units had a battery door on the side of the control box. One thing I noticed when re-installing the battery tray the contacts on the bottom of the tray's PC board would make contact with the control box. What would happen is some arcing of electrical power from the tray to the control box.

Attach a strip of electrical tape on the bottom of the battery tray.

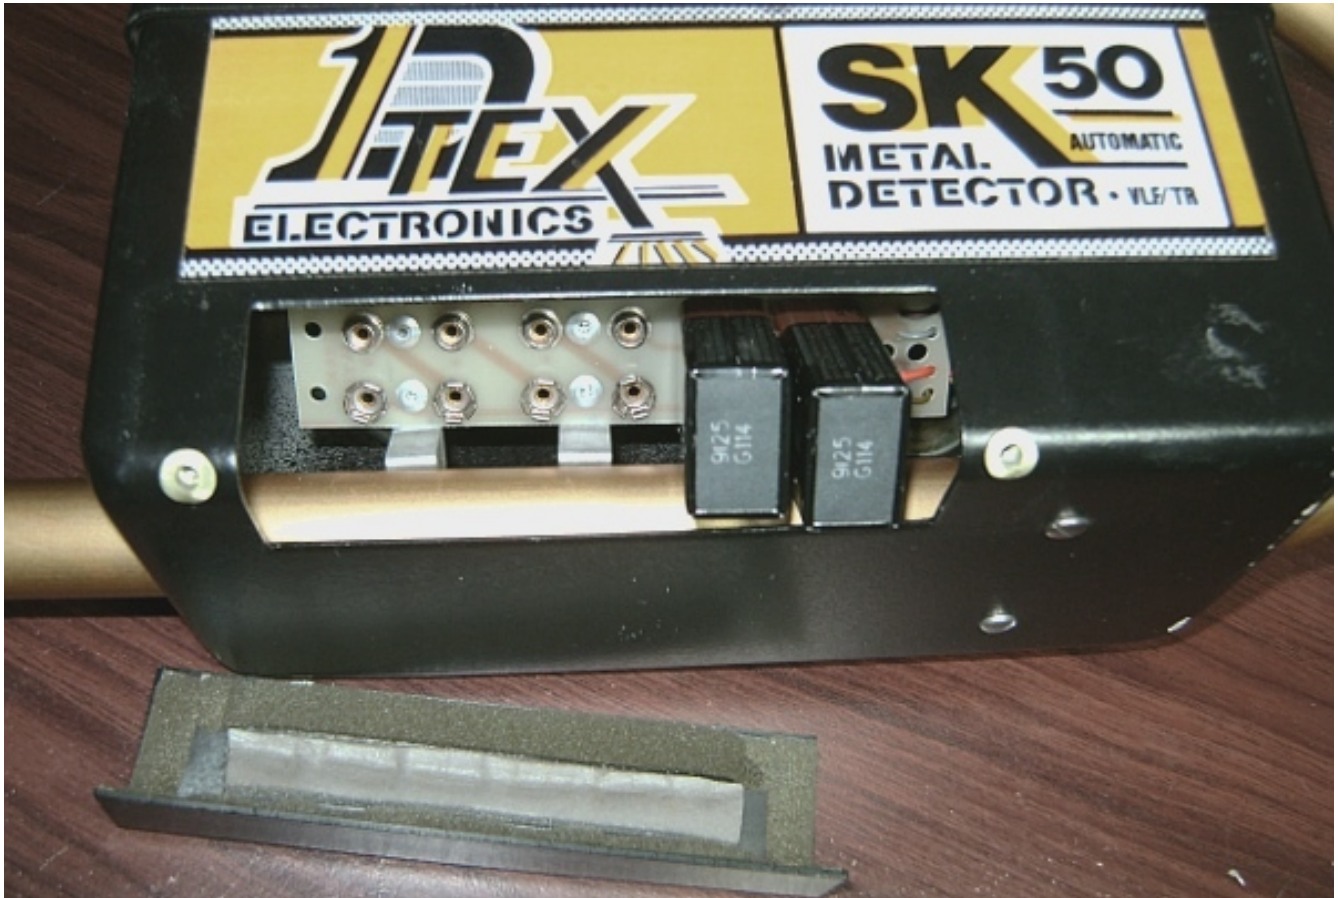
On the newer Dtex control box, the batteries door is now on the bottom edge of the detector. There is no longer a slide in tray. The batteries actually are snapped into the box. There is no longer an arcing problem.
