Inspection Report

310 Windy Hills Drive
Columbus SC

HomeBuyers Inspection HBI

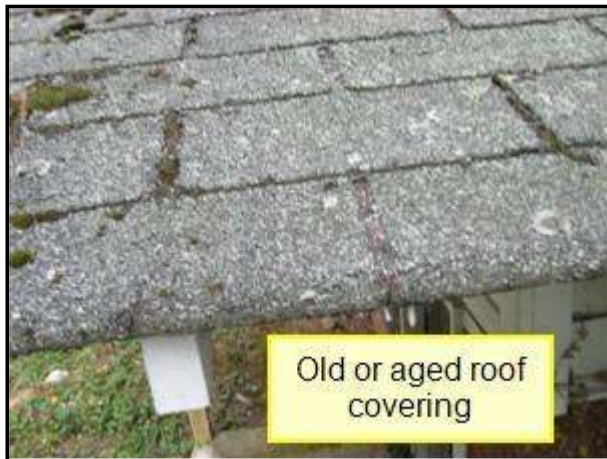
1.0 Picture 1

1.0 (1) The roof covering is old, and the life of covering has expired. The covering does need to be replaced. While it could last a year or so, some areas may need patching with tar as leaks develop. Some shingles are missing on main roof and daylight can be seen from attic. Immediate repairs are needed here.

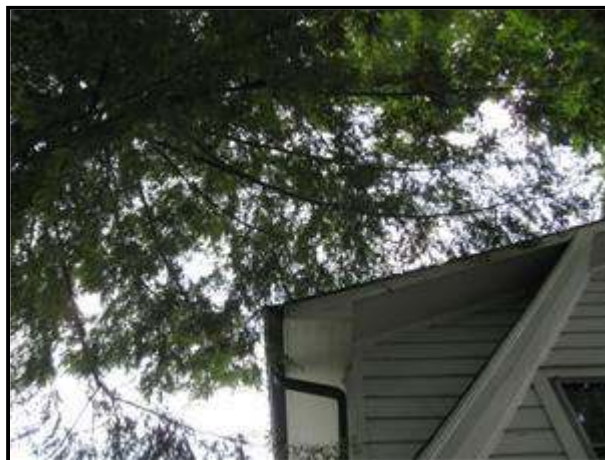
1.0 Picture 3

(2) The tree limbs that are in contact with roof or hanging near roof should be trimmed.

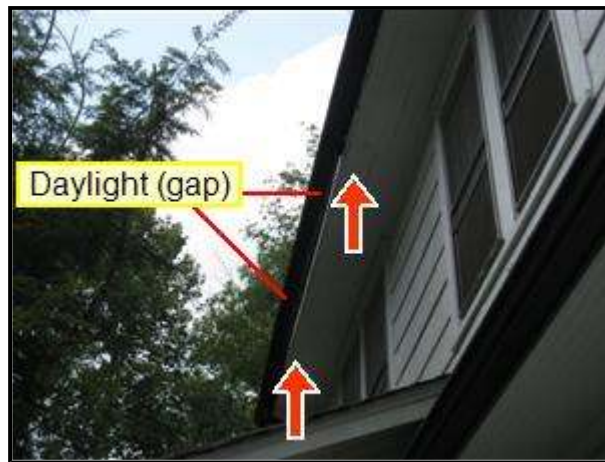
1.3 Picture 1

1.3 (1) The gutter is loose or daylight between gutters and fascia at the rear. Loose or leaking gutters can cause deterioration of fascia, soffit or roof edge. It can also cause gutters to pull loose and lead to possible water intrusion. A qualified contractor should inspect and repair as needed.

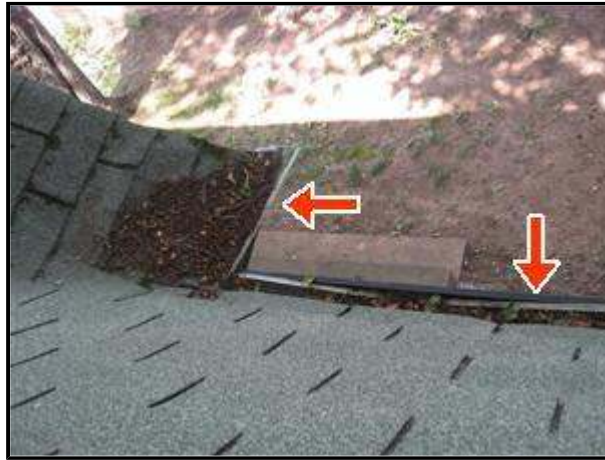
1.3 Picture 2

🏠 (2) The gutter screens collapsed inside gutter at the front of home. A qualified person should repair or replace as needed. The gutter needs cleaning of debris at the front and as needed elsewhere. Gutters that drain poorly or clogged can lead to many costly problems such as deterioration of fascia, soffit or roof edge. It can also cause gutters to pull loose and lead to possible water intrusion. A qualified person should repair or replace as needed.

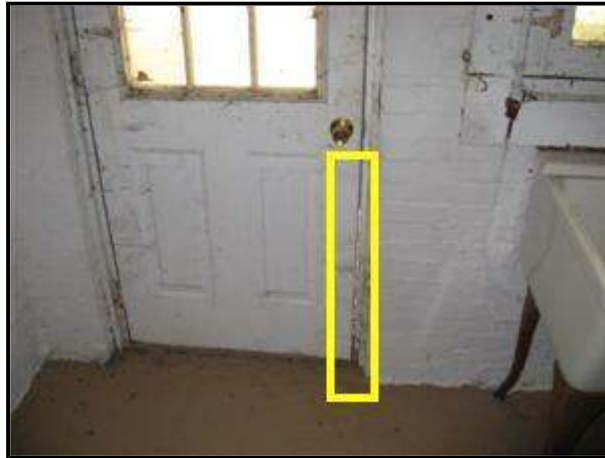
2.1 Picture 1 Basement entry

2.1 The side entry door to basement reveals daylight when latched at areas missing weather-stripping. This is a small repair. A qualified person should repair or replace as needed.

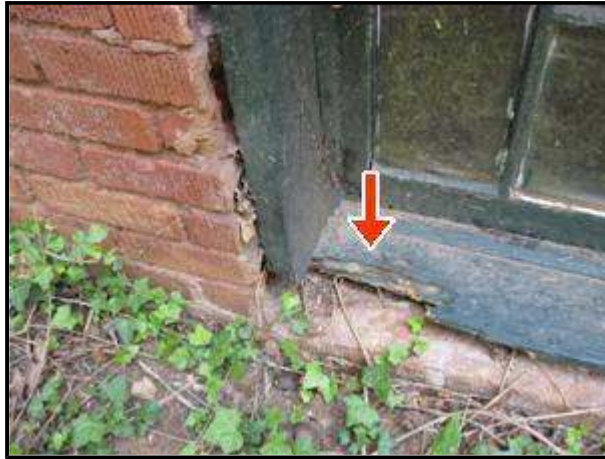
2.2 Picture 1 Basement window (s)

2.2 The sill plate is deteriorated at right side (facing front). This is a small repair. A qualified person should repair or replace as needed.

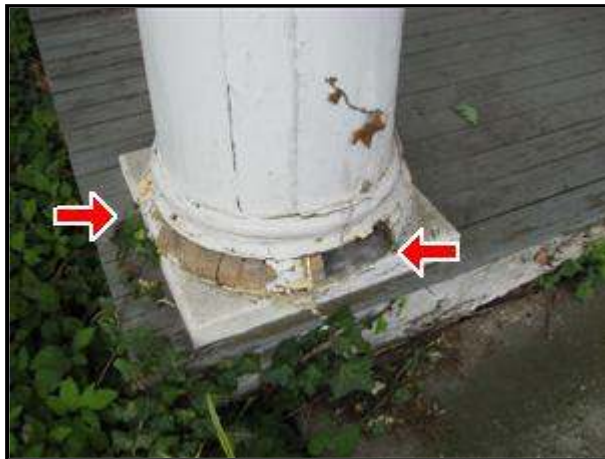
2.3 Picture 1 Front Porch

**2.3** (1) The support column(s) on covered porch at the left side (facing front) are split or cracked in areas and are deteriorated in areas. A repair or replacement is needed. A qualified contractor should perform the work.

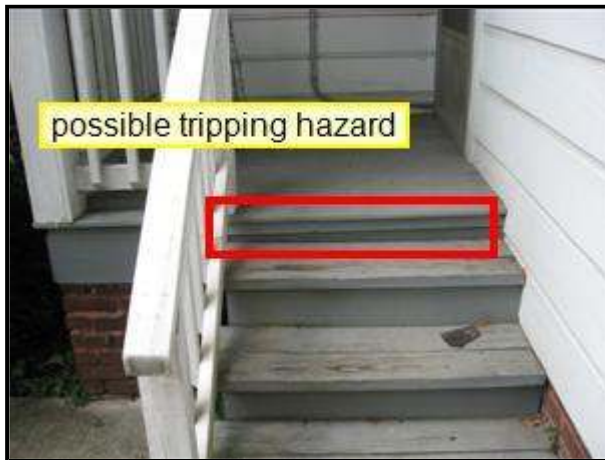
2.3 Picture 2 Rear Porch

(2) The steps on the porch at the rear of home are not uniform in "riser height" and are a tripping hazard. A fall or injury could occur if not corrected. I recommend repair as needed.

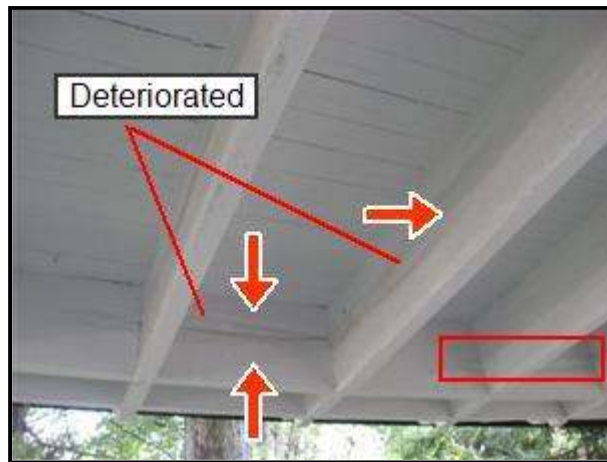
2.3 Picture 3

(3) Some of the rafters of covered porch shows weakening by previous damage from leaks or other. Appears to remain strong to function. FYI

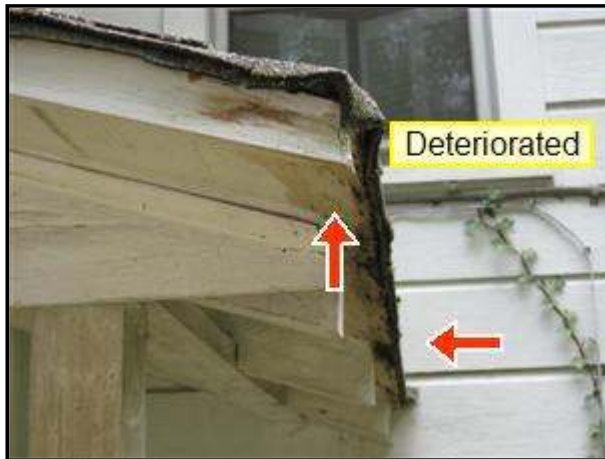
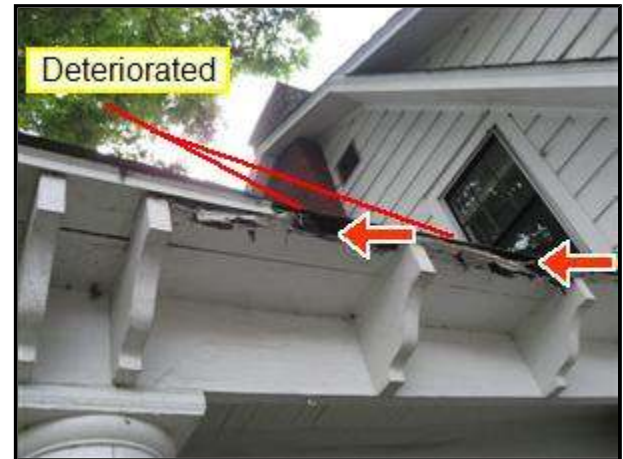
2.5 (1) The eave boards at eave on the gables and various roof edges are deteriorated. Repairs are needed. A qualified contractor should inspect and repair as needed.

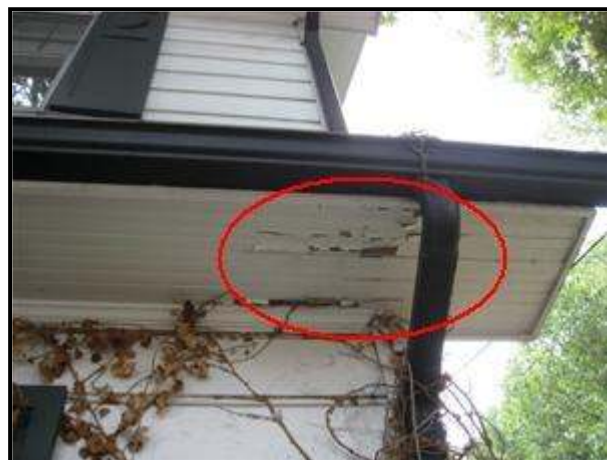
2.5 Picture 3 Front (right of main entry)

2.5 (2) The soffit panel at eave on the front (right of main entry) are weathered and peeling paint. Further deterioration may occur if not repaired. A qualified person should repair or as needed. I am unable to determine if leak exists here or was a result of clogged gutters.

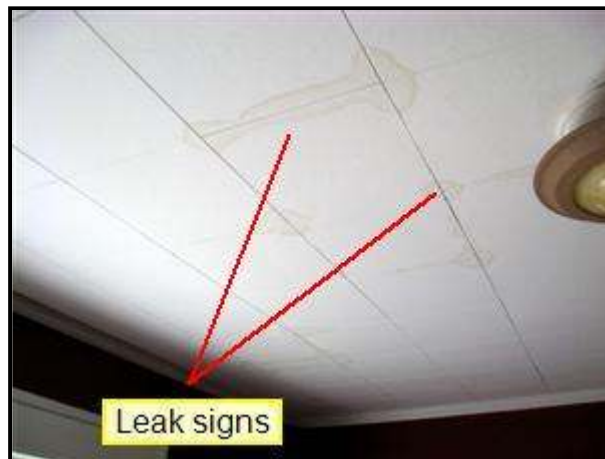
3.0 Picture 2

(2) The Ceiling Tile on the ceiling reveals a water stain indicating a leak did or still exists at the Bedroom. Due to recent dry weather, I am unable to determine if the leak still exists. A qualified contractor should inspect and repair as needed.

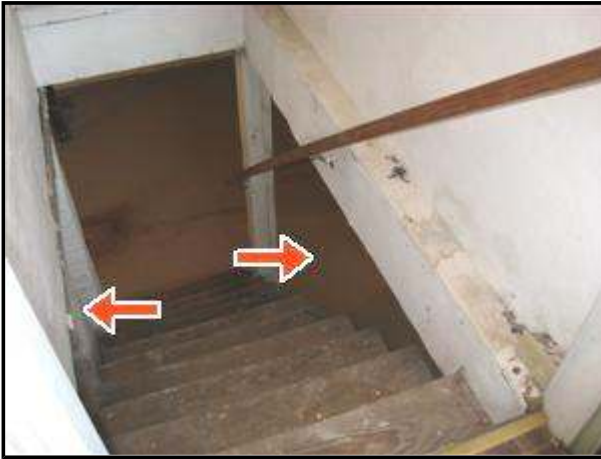
3.3 Picture 1 basement stairs

**3.3** The hand/guard rail for the stairs to basement are missing balusters (on both sides). A fall or injury could occur if not corrected. A qualified contractor should repair or replace as needed.

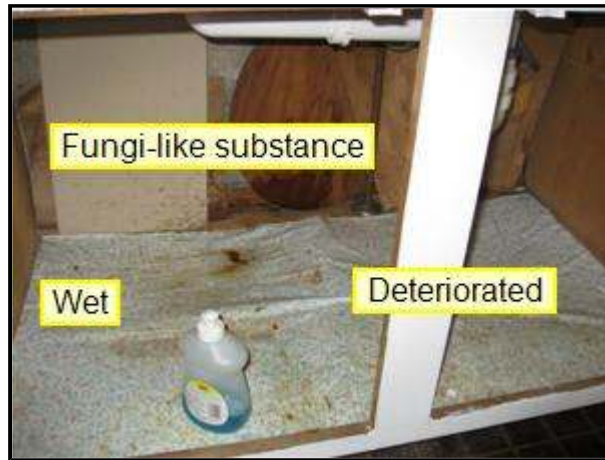
3.4 Picture 1 under kitchen sink

3.4 Sink base is damaged under sink at bottom shelf likely from leaking faucet. Recommend repair or replace sink base cabinetry as necessary.

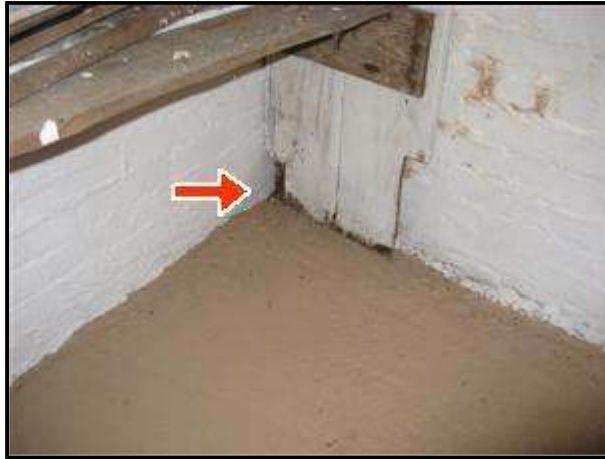
4.0 Picture 2 basement wall

(2) The brick foundation has been coated with a water proof sealer except behind shelving. If water intrusion occurs here, then shelving may need removing in order to coat area properly.

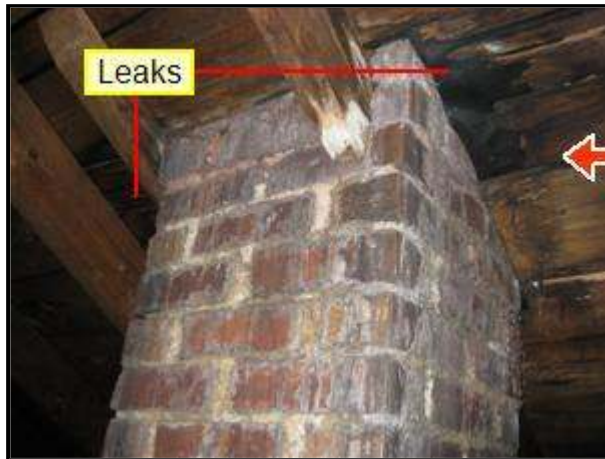
4.5 Picture 1

**4.5** The common board roofing indicates roof leaks or has leaked around the chimneys. Leaking roofs should be repaired to prevent damage. I recommend a qualified contractor perform the work. (See Roof Coverings comments)

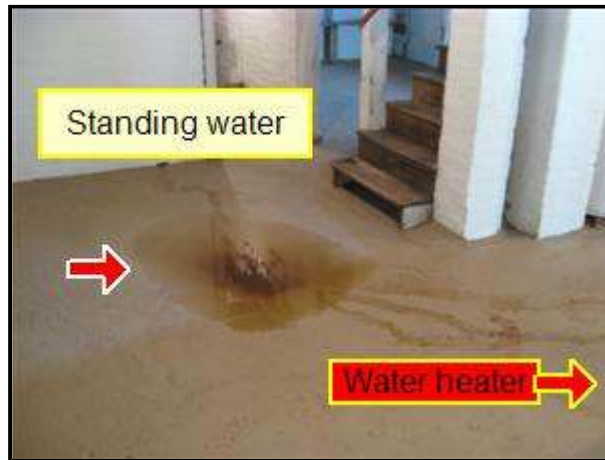
5.0 Picture 1

5.0 (1) Upon arriving water was on and spilling onto floor of basement from nearby faucet and water heater. The hvac person who was their at the time of inspection claimed that he turned the water on at the street. I turned off the valve at faucet and water heater. FYI

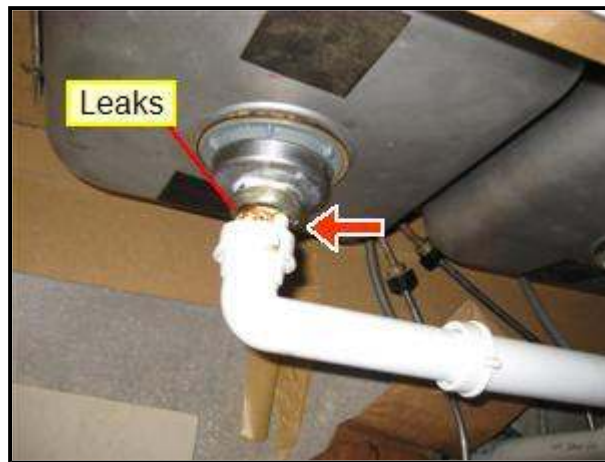
5.0 Picture 3

(3) The basket strainer is leaking at left side and at right side at the Kitchen sink. Repairs are needed. A qualified licensed plumber should repair or correct as needed.

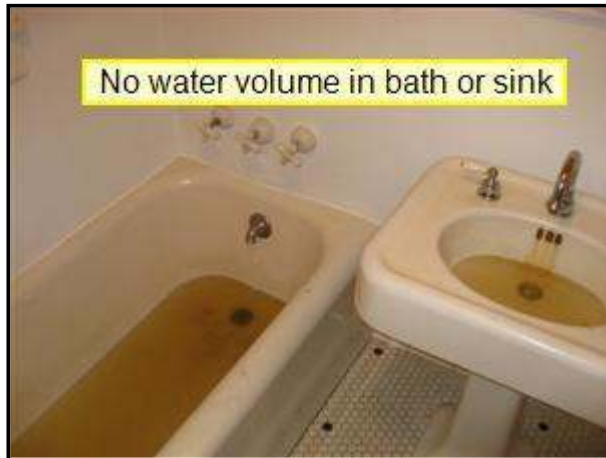
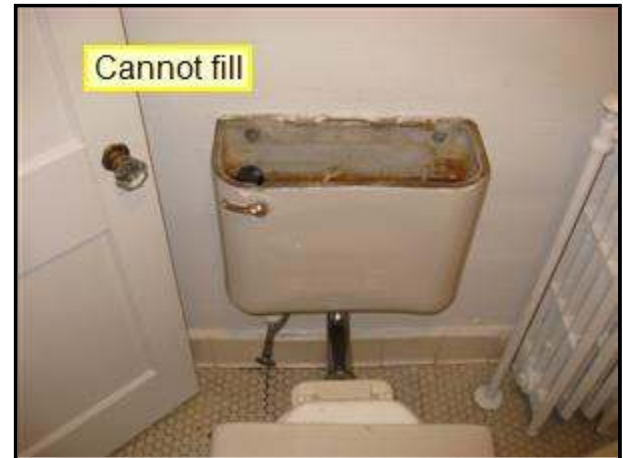
**5.1** (1) The lever on faucet leaks at the kitchen sink. Repairs are needed to stop leaking water from further damaging

the cabinet bottom or to eliminate moisture that may contribute to fungi growth. I recommend repair as necessary by a qualified person. The spray nozzle is not working properly which could be as a result of no volume or pressure at the kitchen sink. Repairs are needed. A qualified licensed plumber should repair or correct as needed.

🏠 (2) The water pressure over-all is poor and would not pass "functional flow." A possible reason for weak volume or pressure could be old galvanized piping that is corroded inside. NOTE: NO SHOWER FOR BATH

Toilet will not fill with water likely due to clogged piping. I could not inspect the toilet fixture for leaks.

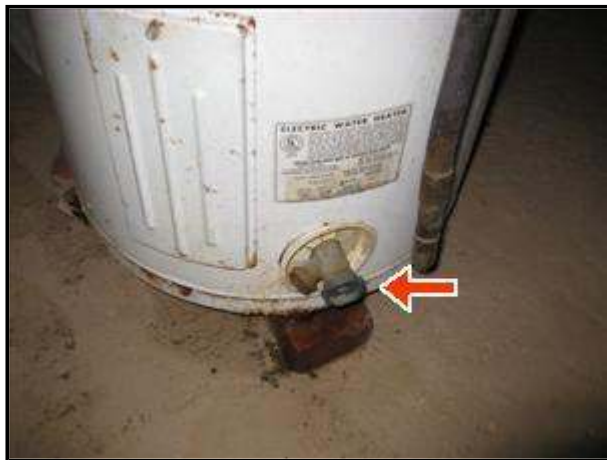
🏠 5.2 Water heater was empty and drain open at bottom when I arrived. I closed drain but at the end of inspection, drips were still occurring. Repairs may be needed.

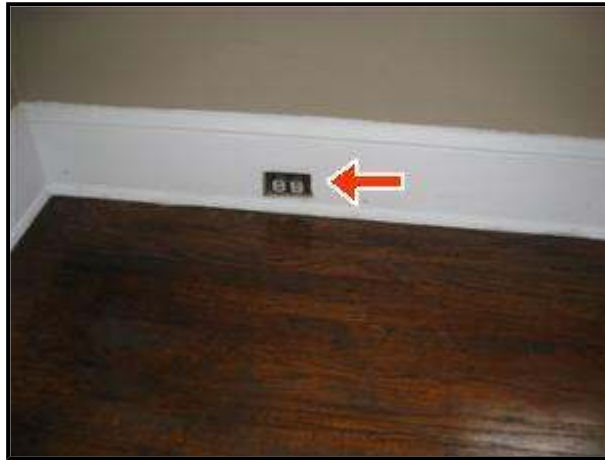
6.3 Picture 1 various rooms

**6.3** (1) "Two-prong" outlets are missing cover-plates in the dining room and in the living room. This is a safety issue that needs to be corrected. I recommend repair as needed.

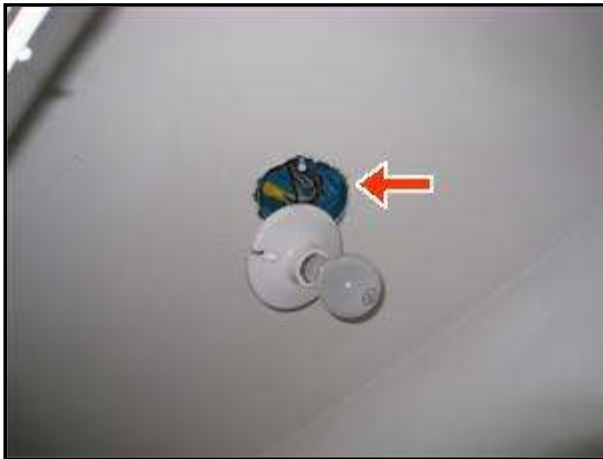
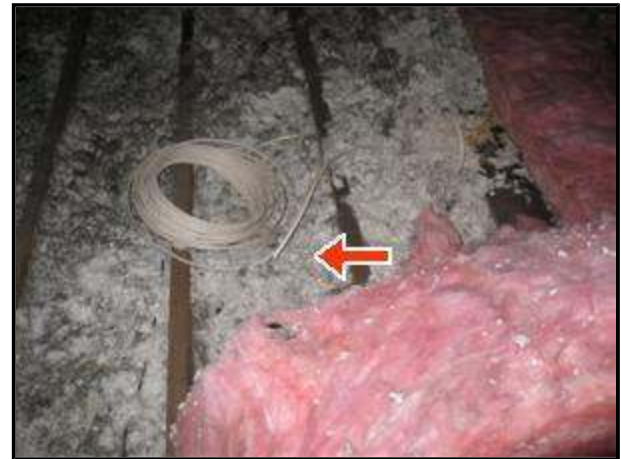
(2) Loose light fixture needs securing in closet. Loose or unfinished wiring in attic should be corrected to remain safe (Picture 2) .One splice box needs a cover-plate in the basement. I recommend repair as needed (Picture 4) .

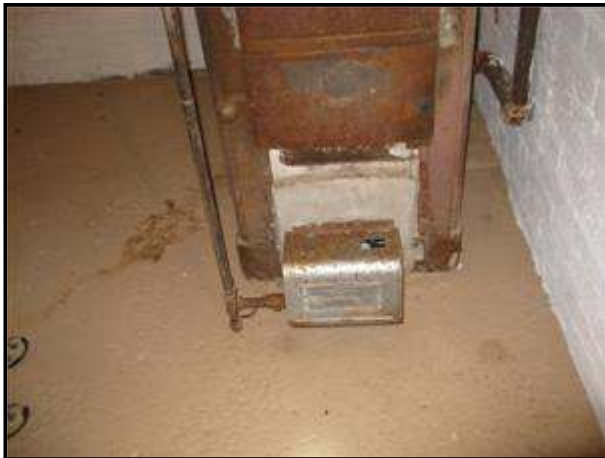
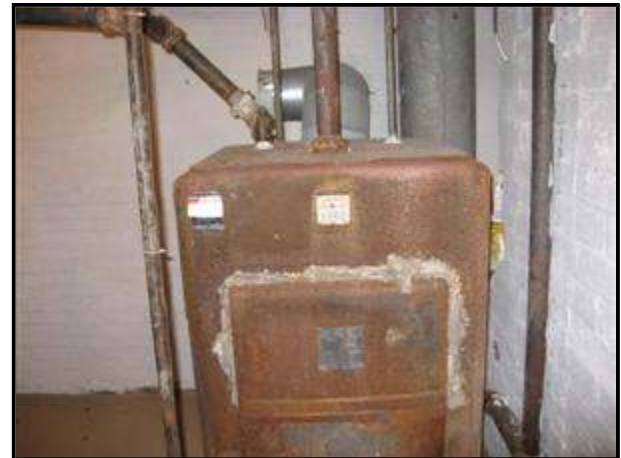
7.0 The gas-fired boiler did not function or is non-operational. A repair or replacement is needed. I recommend further inspection by a licensed HVAC contractor.

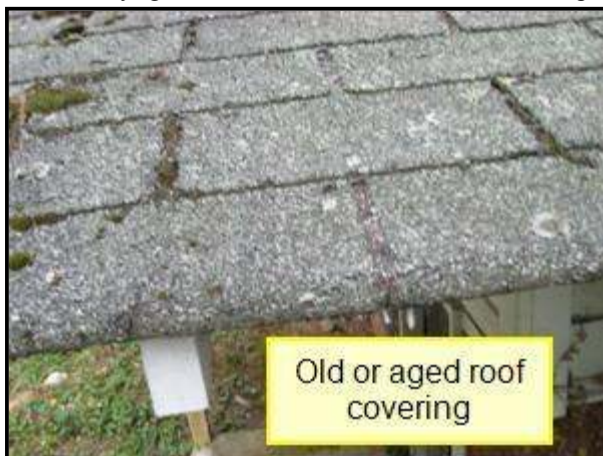
Old or aged roof covering

(1) The roof covering is old, and the life of covering has expired. The covering does need to be replaced. While it could last a year or so, some areas may need patching with tar as leaks develop. Some shingles are missing on main roof and daylight can be seen from attic. Immediate repairs are needed here.

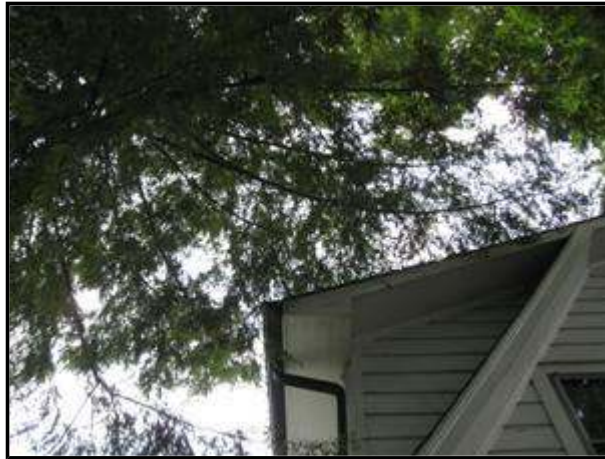
1.0 Picture 3

(2) The tree limbs that are in contact with roof or hanging near roof should be trimmed.

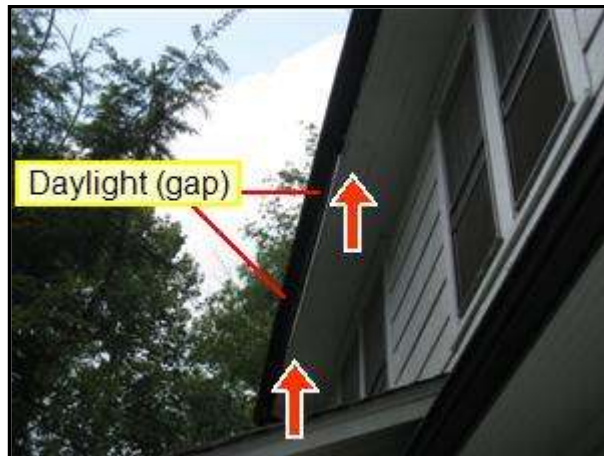
1.3 Picture 1

(1) The gutter is loose or daylight between gutters and fascia at the rear. Loose or leaking gutters can cause deterioration of fascia, soffit or roof edge. It can also cause gutters to pull loose and lead to possible water intrusion. A qualified contractor should inspect and repair as needed.

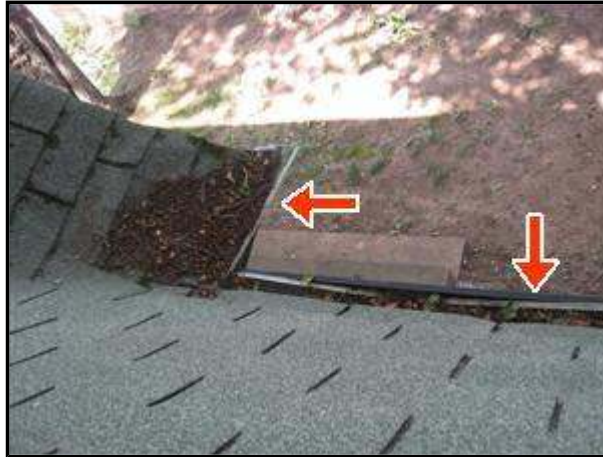
1.3 Picture 2

(2) The gutter screens collapsed inside gutter at the front of home. A qualified person should repair or replace as

needed. The gutter needs cleaning of debris at the front and as needed elsewhere. Gutters that drain poorly or clogged can lead to many costly problems such as deterioration of fascia, soffit or roof edge. It can also cause gutters to pull loose and lead to possible water intrusion. A qualified person should repair or replace as needed.

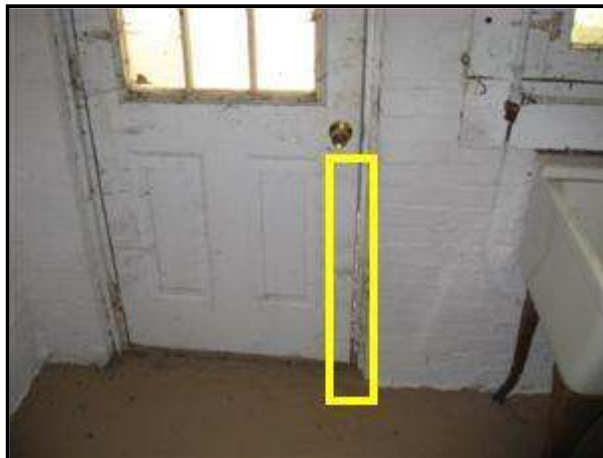
2.1 Picture 1 Basement entry

The side entry door to basement reveals daylight when latched at areas missing weather-stripping. This is a small repair. A qualified person should repair or replace as needed.

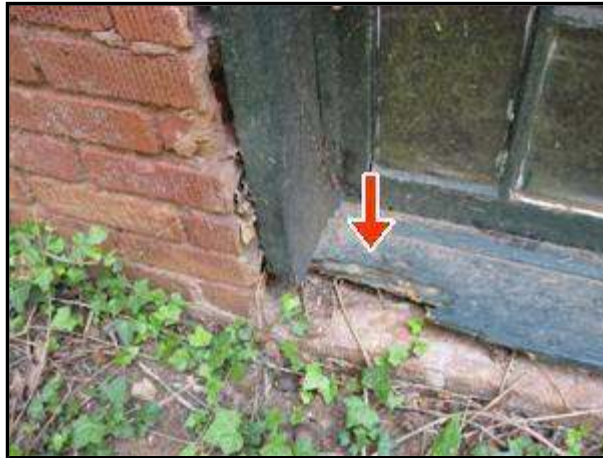
2.2 Picture 1 Basement window (s)

The sill plate is deteriorated at right side (facing front). This is a small repair. A qualified person should repair or replace as needed.

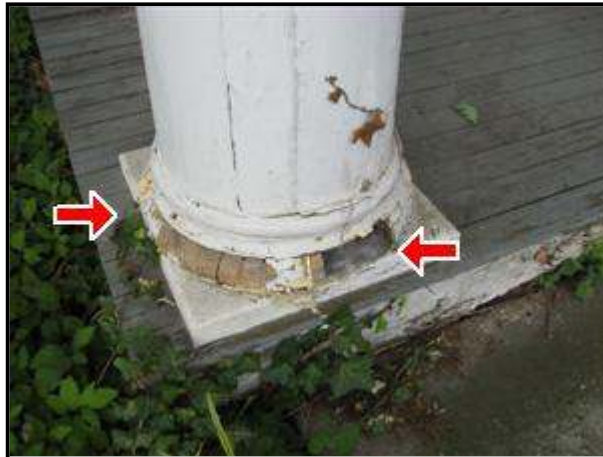
2.3 Picture 1 Front Porch

(1) The support column(s) on covered porch at the left side (facing front) are split or cracked in areas and are deteriorated in areas. A repair or replacement is needed. A qualified contractor should perform the work.

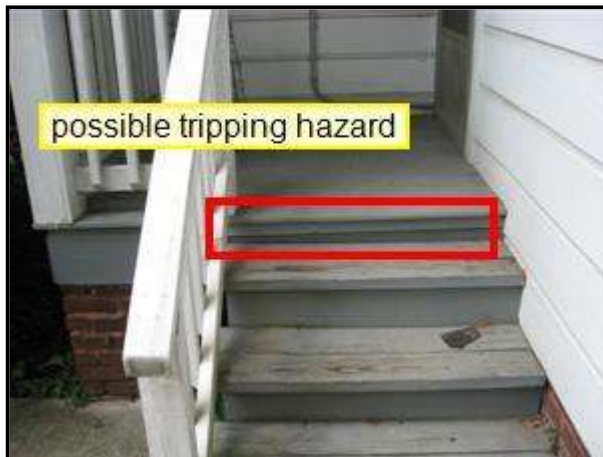
(2) The steps on the porch at the rear of home are not uniform in "riser height" and are a tripping hazard. A fall or injury could occur if not corrected. I recommend repair as needed.

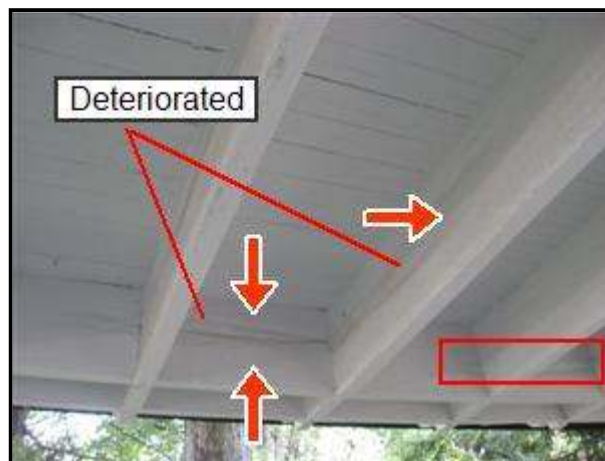
2.3 Picture 3

- (3) Some of the rafters of covered porch shows weakening by previous damage from leaks or other. Appears to remain strong to function. FYI

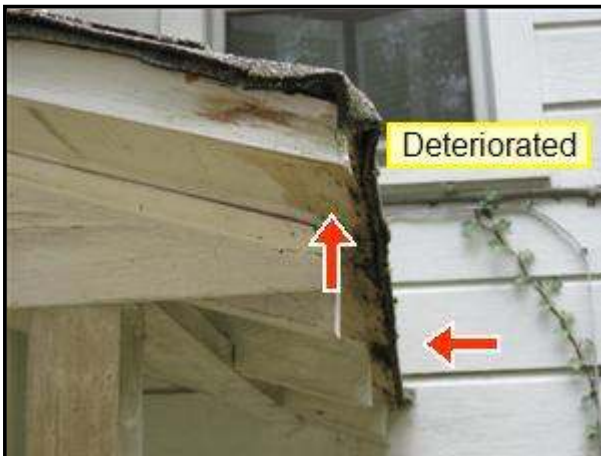
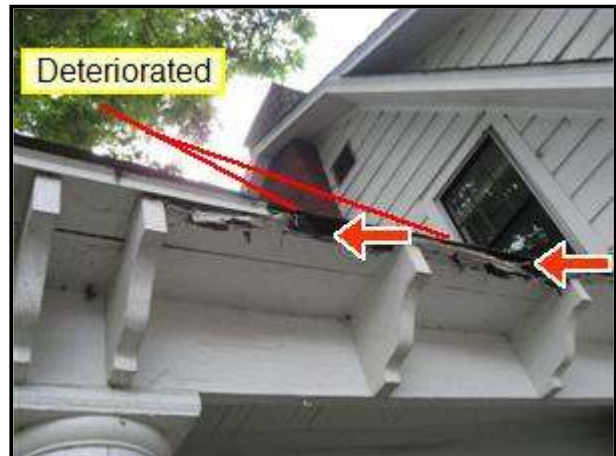
- (1) The eave boards at eave on the gables and various roof edges are deteriorated. Repairs are needed. A qualified contractor should inspect and repair as needed.

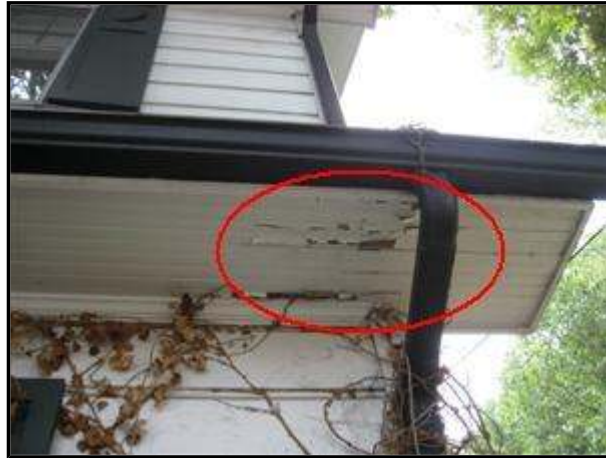
2.5 Picture 3 Front (right of main entry)

- (2) The soffit panel at eave on the front (right of main entry) are weathered and peeling paint. Further deterioration

may occur if not repaired. A qualified person should repair or as needed. I am unable to determine if leak exists here or was a result of clogged gutters.

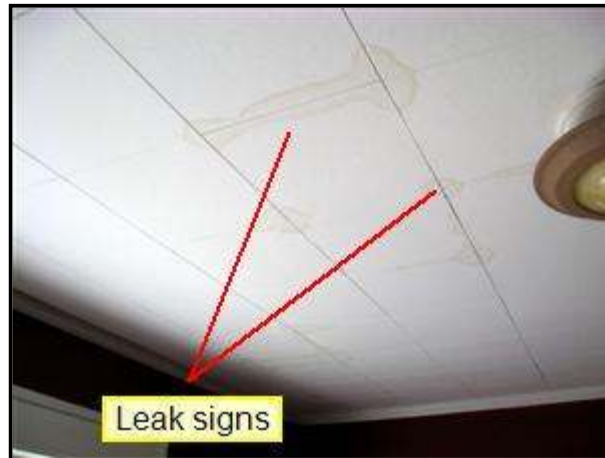
3.0 Picture 2

(2) The Ceiling Tile on the ceiling reveals a water stain indicating a leak did or still exists at the Bedroom. Due to recent dry weather, I am unable to determine if the leak still exists. A qualified contractor should inspect and repair as needed.

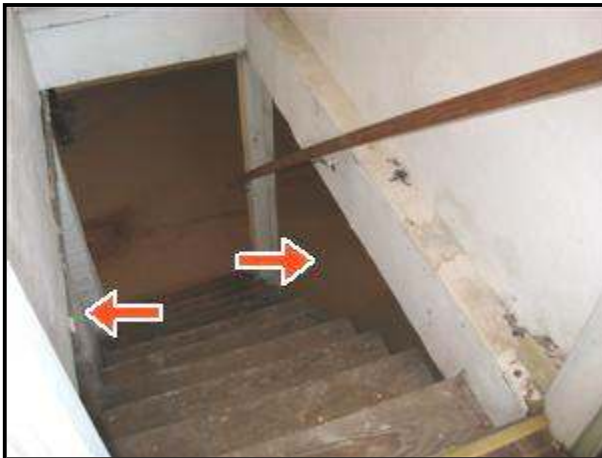
3.3 Picture 1 basement stairs

The hand/guard rail for the stairs to basement are missing balusters (on both sides). A fall or injury could occur if not corrected. A qualified contractor should repair or replace as needed.

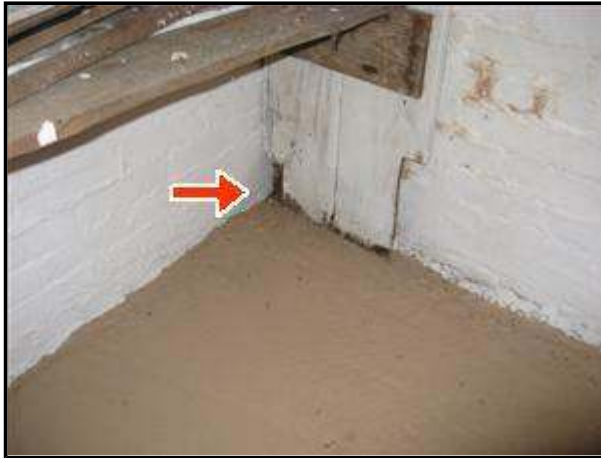
4.0 Picture 2 basement wall

(2) The brick foundation has been coated with a water proof sealer except behind shelving. If water intrusion occurs here, then shelving may need removing in order to coat area properly.

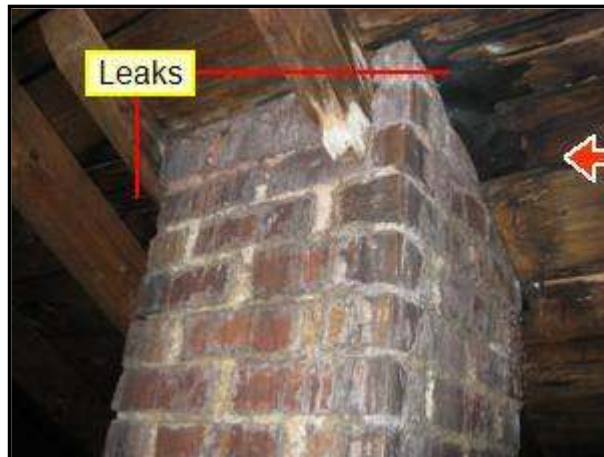
4.5 Picture 1

The common board roofing indicates roof leaks or has leaked around the chimneys. Leaking roofs should be repaired to prevent damage. I recommend a qualified contractor perform the work. (See Roof Coverings comments)

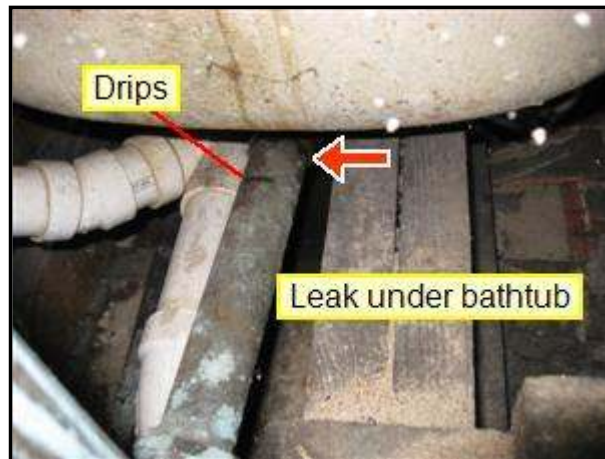
5.0 Picture 2 Upstairs bath

(2) The stop-valve does not work properly at the Hall Bath sink. Repairs are needed. The tub drain drains slowly at main bath. There is a leak under bathtub that can be seen from removing access panel on wall. Repairs are needed. A qualified licensed plumber should repair or correct as needed.

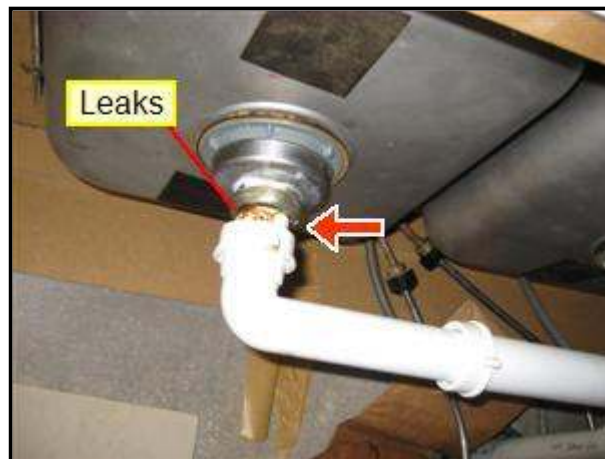
5.0 Picture 3

(3) The basket strainer is leaking at left side and at right side at the Kitchen sink. Repairs are needed. A qualified licensed plumber should repair or correct as needed.

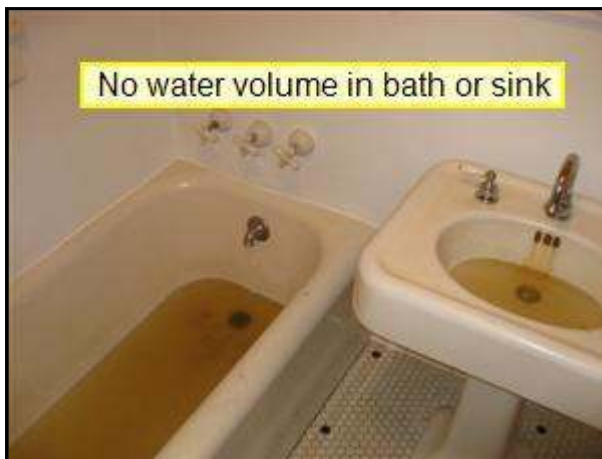
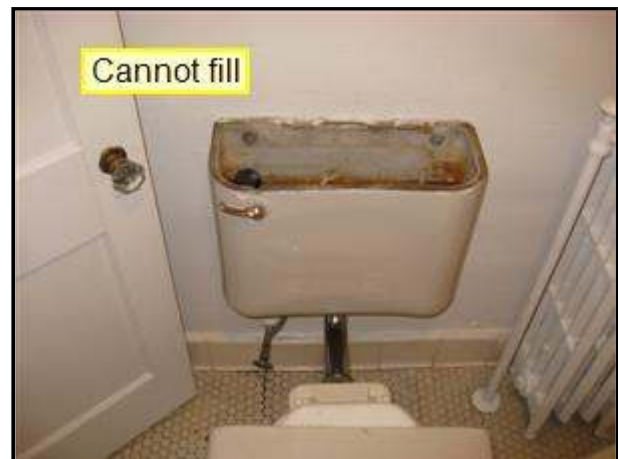
Toilet will not fill with water likely due to clogged piping. I could not inspect the toilet fixture for leaks.

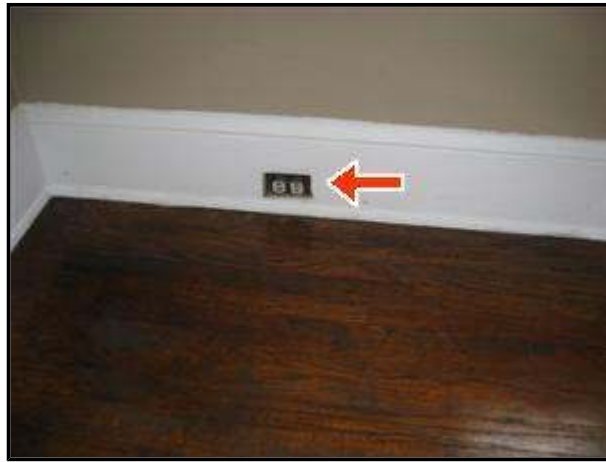
6.3 Picture 1 various rooms

- 🏠 (1) "Two-prong" outlets are missing cover-plates in the dining room and in the living room. This is a safety issue that needs to be corrected. I recommend repair as needed.

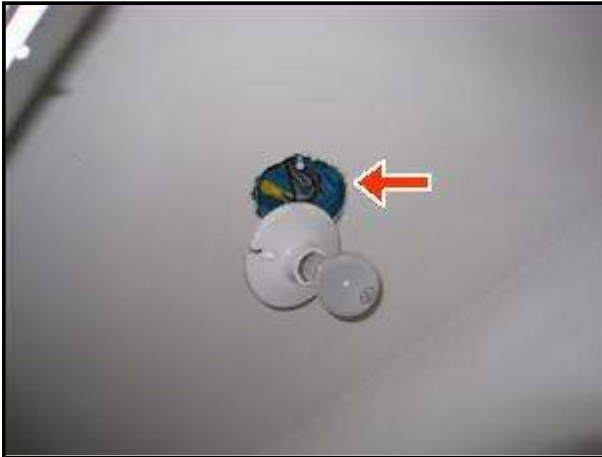
6.3 Picture 2

- 🏠 (2) Loose light fixture needs securing in closet. Loose or unfinished wiring in attic should be corrected to remain safe (Picture 2) .One splice box needs a cover-plate in the basement. I recommend repair as needed (Picture 4) .

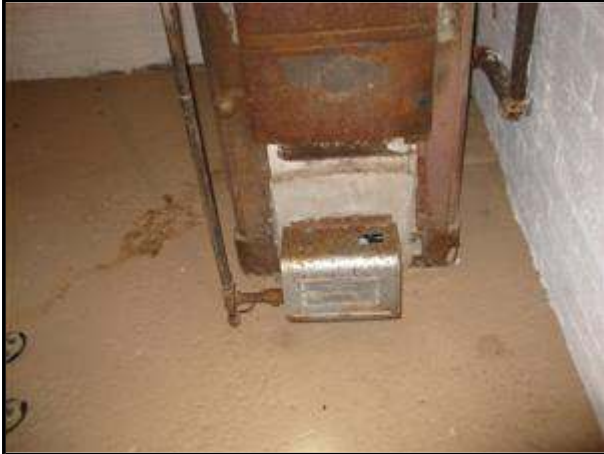
7.0 Picture 1

- The gas-fired boiler did not function or is non-operational. A repair or replacement is needed. I recommend further inspection by a licensed HVAC contractor.
