Real Estate Inspection Report

1234 Anywhere Dr
Marco Island, FL 34145

Eyezon Home Inspectors

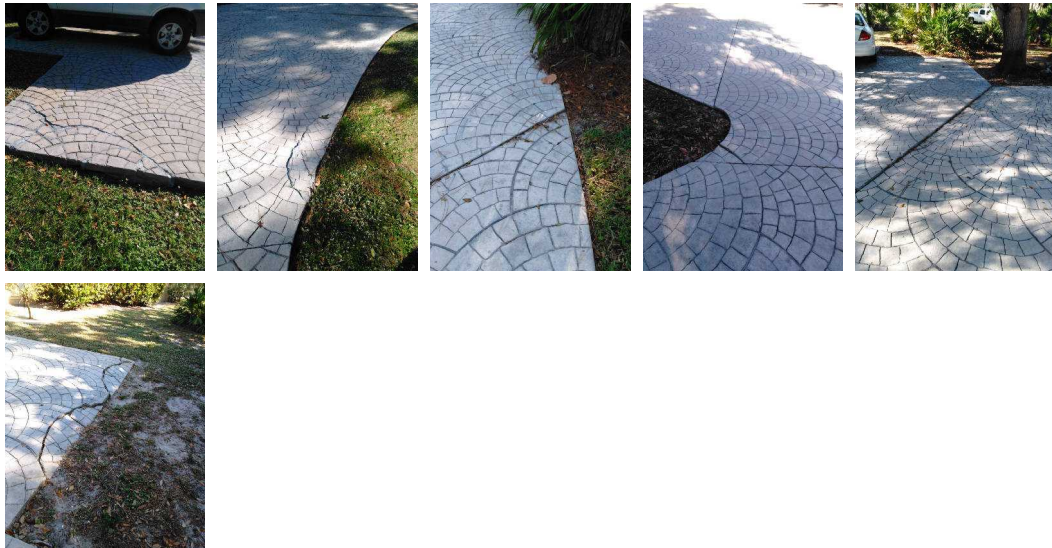
1. Defective

Driveway: **Stamped Concrete - Uneven settling, Heaves in concrete causing trip hazard, Damaged or deteriorated, recommend estimate for repair or replacement by a licensed contractor**

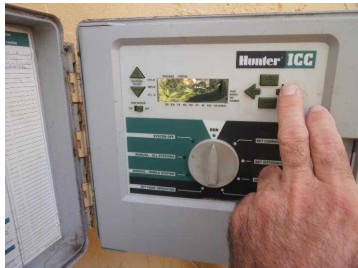
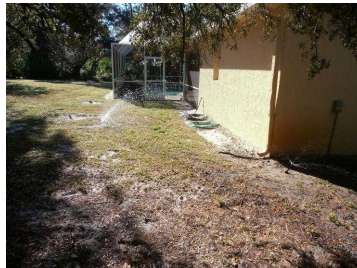
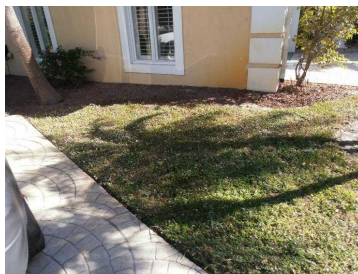
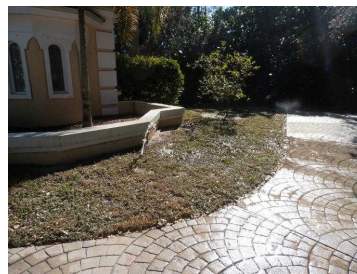
8. Defective

Lawn Sprinklers: **Front and back yard - Inoperative at time of inspection, tested using manual mode of timer. Timer not tested, pump zone start relay appears to be defective and was making a loud buzzing noise. Sprinkler line(s) and or head damage noted, I recommend a qualified irrigation contractor go through entire sprinkler system, evaluate and or repair all that is needed for proper operation, adjust/repair all sprinkler heads, and educate the new homeowner of proper operation.**

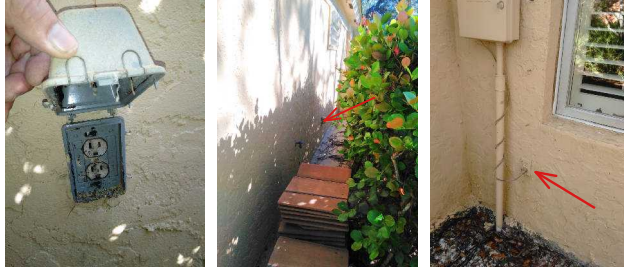
Exterior Electric Outlets: (continued)

11. **Defective** Exterior Electric Outlets: **110 VAC - Inoperative at time of inspection, Outlets have visible corrosion, Loose or missing moisture cover**

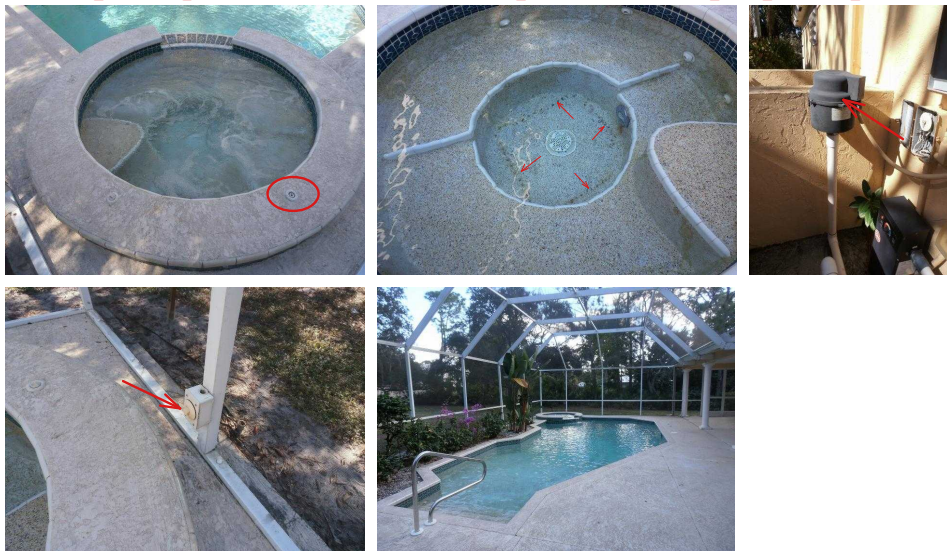
1. **Marginal, Defective** Type: In ground with spa - **Blower for spa jets does not work, pump air jet adjustment cap on spa deck is missing. Appears that individual pump timers for spa and pool are tied into one main timer. Did not locate child safety screens for pool deck protection. Check with current owner if possible. A licensed pool company is recommended to go through and evaluate complete system and specify what all needs repaired for proper operation**

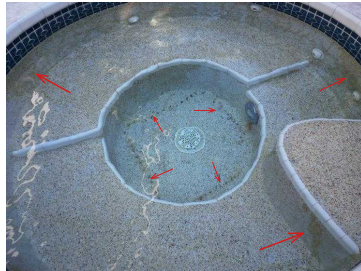
3. **Acceptable, Marginal** Liner: Diamond Brite/PebbleTech - Appeared to be blotches or irregularities on pool lining surface, this may just be spots of dirt or debris and may just need good cleaning or chemical staining, further examination by a qualified pool tech is recommended as this is outside the scope of a Florida Licensed Home Inspector. Rust or water stains noted at spa jets on bottom of spa surface.

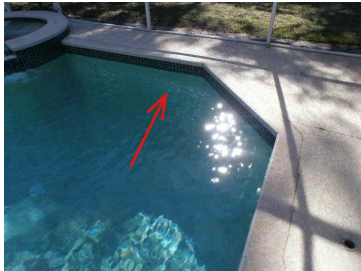
4. **Defective** Pool Light Submersed - Pool and spa light did not come with switch, Water/rust stains noted at bottom of pool light. Further evaluation by a qualified pool tech is recommended

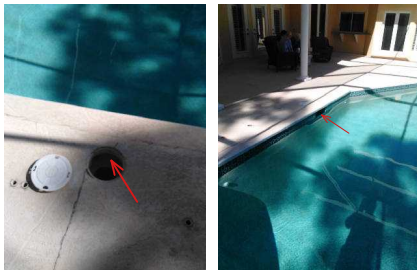
8. **Marginal** Skimmer: Functioning - Missing skimmer flapper door, flapper door should be in place to prevent larger objects such as pool toys (balls) from entering skimmer and possibly blocking suction pump which would damage the pool pump itself

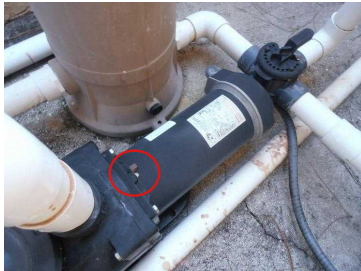
Pump Motor: **Century** - Ground wire on pump is not connected, Air bubbles noted in the pumps strainer pot or filter basket this is generally caused from one of three things on the suction side of the pump. One - the pool water level being too low therefore sucking air through the strainer. Two - the rubber O ring in the pump connector coupler being bad or not correctly in place. Three - the clear plastic view cover on the strainer pot not secured tightly. Further evaluation recommended.

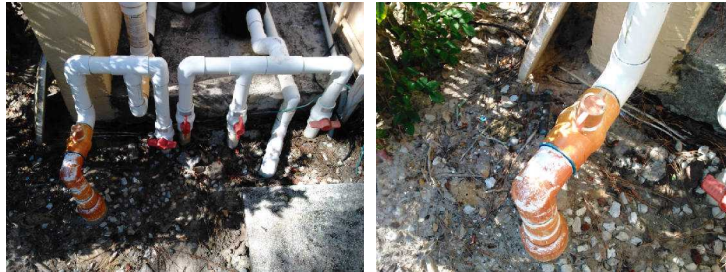
11. Acceptable, Marginal Shut-off Valve: **Ball valves** - No valve's are labeled for user to know what function they serve, Handle broken

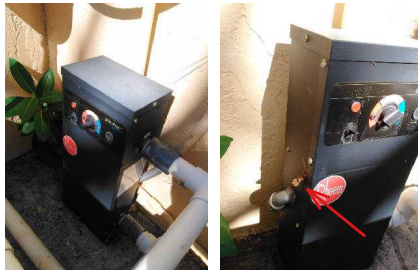
13. Marginal, Defective Heater: **Rheem** - Not properly grounded, missing ground wire, Would not function, power light came on but did not appear to be heating. Further evaluation by a licensed pool tech is recommended.

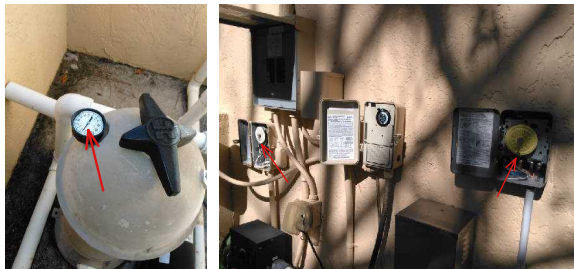
Gauges and Controls: **Hayward**, Functioning - Broken cover, Damaged needs replaced

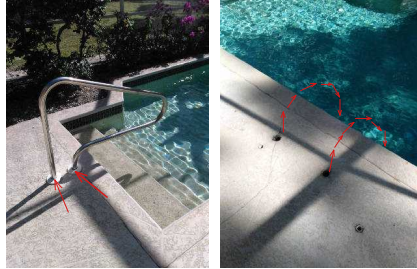
15. Not Present, Marginal Ladder/Steps: Stainless steel hanging, Built in step with handrail - Hanging steps have been removed. built in step handrail is loose, needs to be secured

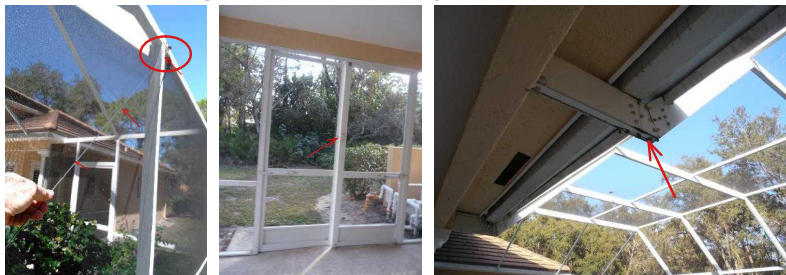
16. Marginal Pool Enclosure: Screen cage - Screen cage tension cables are loose and should be tightened. These cables help prevent the cage from moving in windy or bad weather conditions, when this happens it also stretches the screens causing them to become loose or torn. Pool cage door latch requires adjustment to open and close properly. Evidence of water leak noted at cage frame and gutter connection. Dry day unable to verify

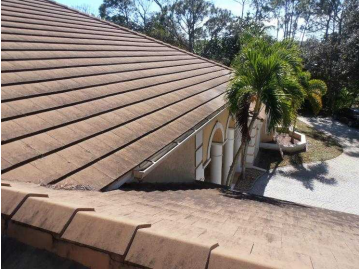
2. **Acceptable**

Material: **Cement tile** - **Trees and shrubs should be trimmed back and off roof to prevent unnecessary or premature damage to roofing material**

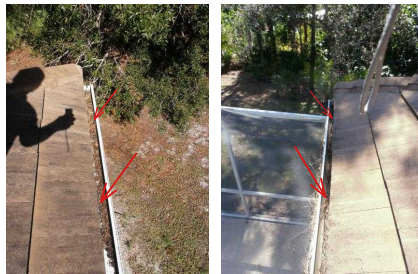
8. **Acceptable, Marginal** Gutters: **Aluminum, Boxed** - **Gutters have some debris (pine needles) in them. Periodic cleaning to maintain proper water flow is recommended, Dry day, unable to check for proper water flow, however no gutters were holding water when observed from roof**

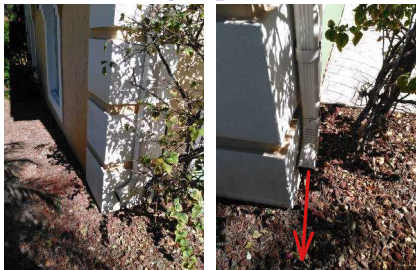
Leader/Extension: **Missing or damaged** - **Some splash blocks are missing. installing splash blocks or leaders to move water away from foundation.**

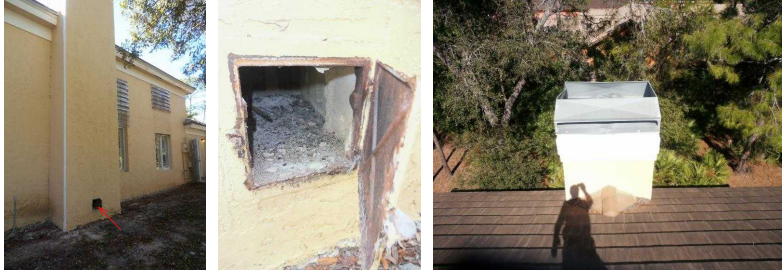
11. **Acceptable** Chimney: **Block** - **Unable to view interior of chimney due to height, photo of clean out**

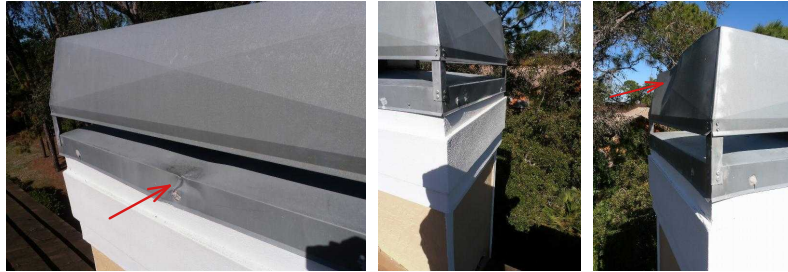
12. **Acceptable, Not Inspected** Flue/Flue Cap: **Metal** - **Metal cap slightly dented, cosmetic only, probably got dented in hurricane. Chimney lining could not be inspected due to rain cap**

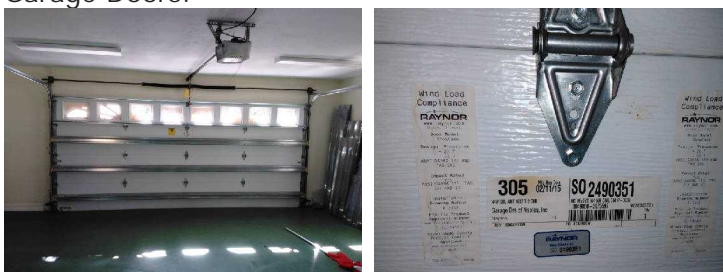
Front of home Garage

1. Type of Structure: **Attached** Car Spaces: **2**
2. **Acceptable** Garage Doors: **Insulated aluminum**

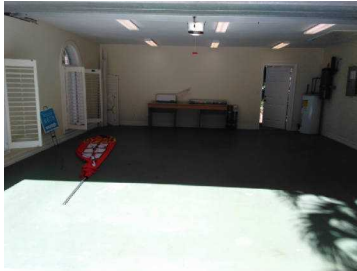
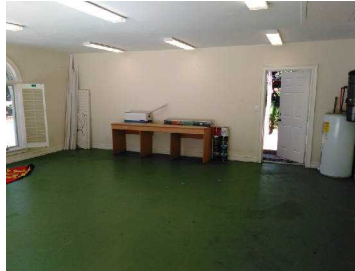
- 11. **Acceptable**
 - 12. **Acceptable, Not Inspected**
- Electrical: **110 VAC GFCI**
Windows: **Wood casement - The window will not open due to hurricane panel hardware installed**

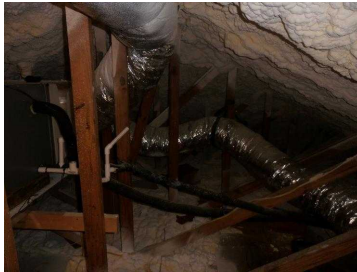
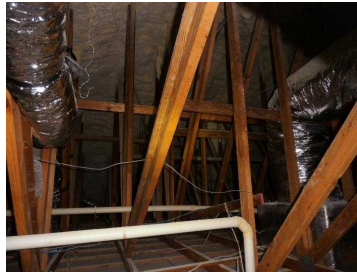
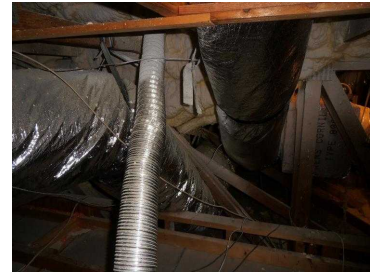
3. **Acceptable** Roof Framing: **2x6, 2x4 Truss**
4. **Acceptable** Sheathing: **Unknown, covered with spray foam insulation**

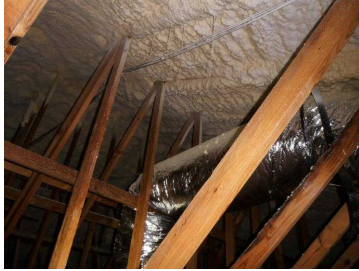
7. **Acceptable**

Insulation Depth: **6"**

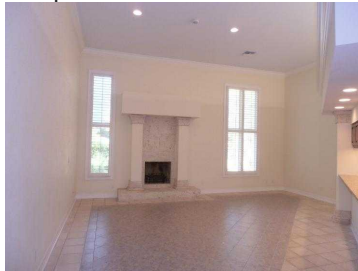
1. **Acceptable**

Fireplace Construction: **Block**

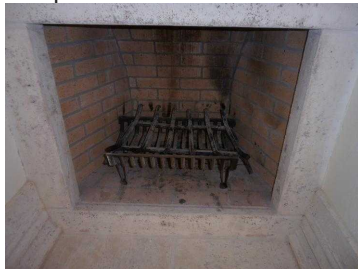
3. **Acceptable**

Fireplace Insert: **Standard**

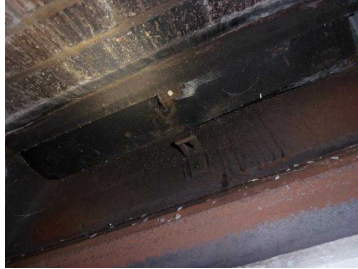
Damper: **Metal** - **Damper latch is missing or broken, cannot secure damper in closed position to prevent conditioned air in home from escaping through chimney flue when not in use**

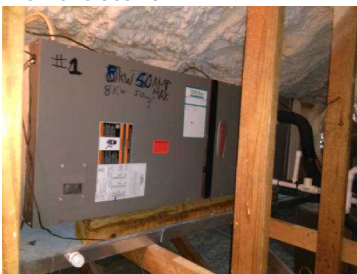
1. **Acceptable** Heating System Operation: **Appears functional** - **2013 mfg date (code) on air handler ID plate**

2. Manufacturer: **Lennox**

3. Model Number: **CBX27UH048230603** Serial Number: **1613F03051**

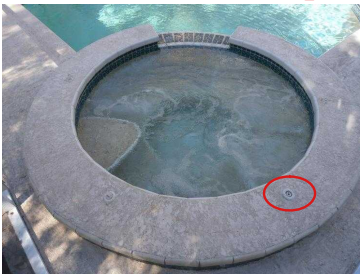
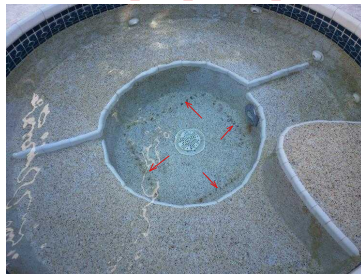
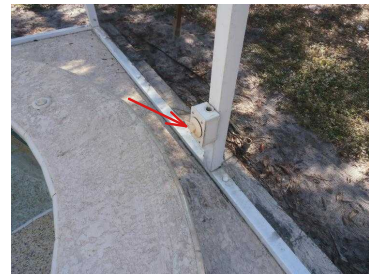
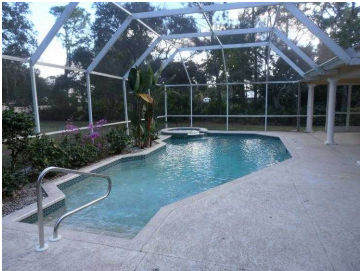
7. Behind home Swimming Pool Type: **In ground with spa - Blower for spa jets does not work, pump air jet adjustment cap on spa deck is missing. Appears that individual pump timers for spa and pool are tied into one main timer. Did not locate child safety screens for pool deck protection. Check with current owner if possible. A licensed pool company is recommended to go through and evaluate complete system and specify what all needs repaired for proper operation**

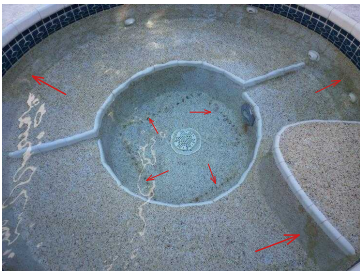
8. Behind home Swimming Pool Liner: **Diamond Brite/PebbleTech - Appeared to be blotches or irregularities on pool lining surface, this may just be spots of dirt or debris and may just need good cleaning or chemical staining, further examination by a qualified pool tech is recommended as this is outside the scope of a Florida Licensed Home Inspector. Rust or water stains noted at spa jets on bottom of spa surface.**

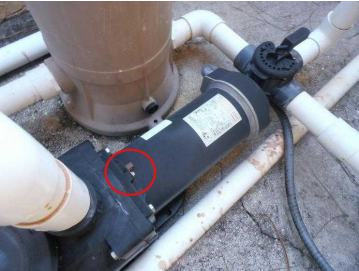
10. Behind home Swimming Pool Pump Motor: **Century** - Ground wire on pump is not connected, Air bubbles noted in the pumps strainer pot or filter basket this is generally caused from one of three things on the suction side of the pump. One - the pool water level being too low therefore sucking air through the strainer. Two - the rubber O ring in the pump connector coupler being bad or not correctly in place. Three - the clear plastic view cover on the strainer pot not secured tightly. Further evaluation recommended.

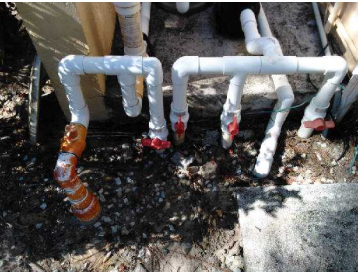
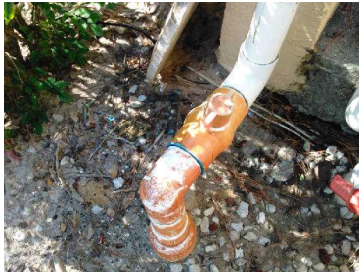
11. Behind home Swimming Pool Shut-off Valve: **Ball valves** - No valve's are labeled for user to know what function they serve, Handle broken

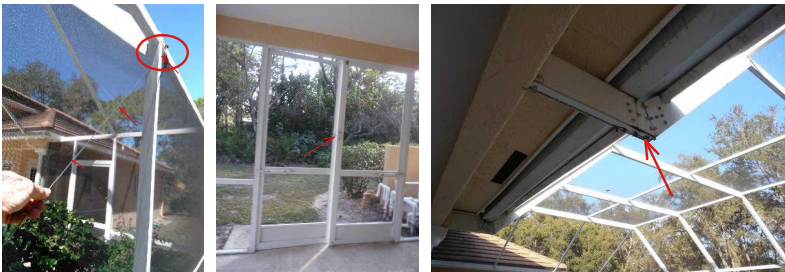
15. Behind home Swimming Pool Pool Enclosure: **Screen cage** - **Screen cage tension cables are loose and should be tightened. These cables help prevent the cage from moving in windy or bad weather conditions, when this happens it also stretches the screens causing them to become loose or torn. Pool cage door latch requires adjustment to open and close properly. Evidence of water leak noted at cage frame and gutter connection. Dry day unable to verify**

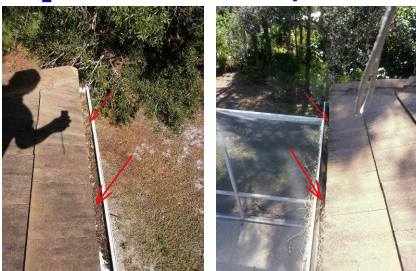
16. Gutters: **Aluminum, Boxed** - **Gutters have some debris (pine needles) in them. Periodic cleaning to maintain proper water flow is recommended, Dry day, unable to check for proper water flow, however no gutters were holding water when observed from roof**

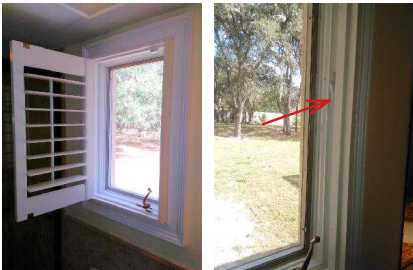
20. Pool bath Bathroom Windows: **Wood casement** - **The window will not open, blocked with shutters or shutter hardware**

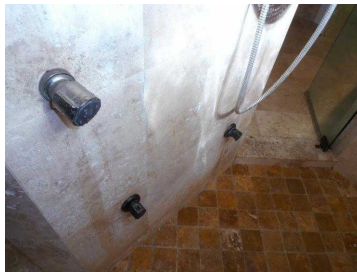
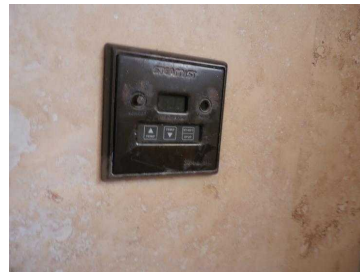
23. Master Bathroom Shower/Surround: **Tile pan and tile surround - Cracked grout in corners of shower surround, this is typical of cement based grout being used for corner applications due to expansion and contraction. Recommend replacing with grout "caulk" to help prevent moisture intrusion. Grout caulk can be located in the tile section at most hardware stores, Steamer for shower was not in use at time of inspection. Note on main electrical panel to leave steamer breaker in OFF position. Steam unit is located in attic. Touch control pad in bathroom shower shows signs of corrosion. Further evaluation by a licensed plumbing contractor is recommended.**

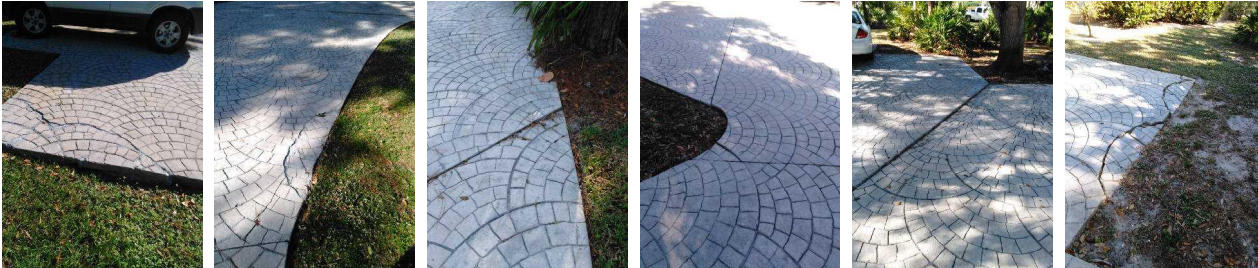
1. Driveway: **Stamped Concrete** - **Uneven settling, Heaves in concrete causing trip hazard, Damaged or deteriorated, recommend estimate for repair or replacement by a licensed contractor**

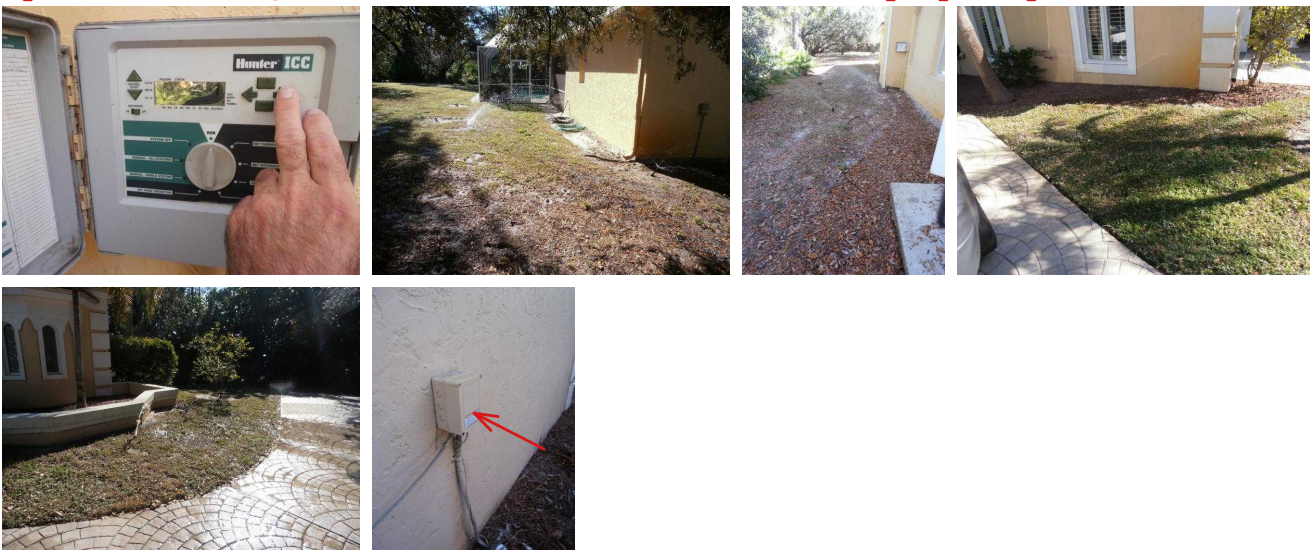
3. Lawn Sprinklers: **Front and back yard** - **Inoperative at time of inspection, tested using manual mode of timer. Timer not tested, pump zone start relay appears to be defective and was making a loud buzzing noise. Sprinkler line(s) and or head damage noted, I recommend a qualified irrigation contractor go through entire sprinkler system, evaluate and or repair all that is needed for proper operation, adjust/repair all sprinkler heads, and educate the new homeowner of proper operation.**

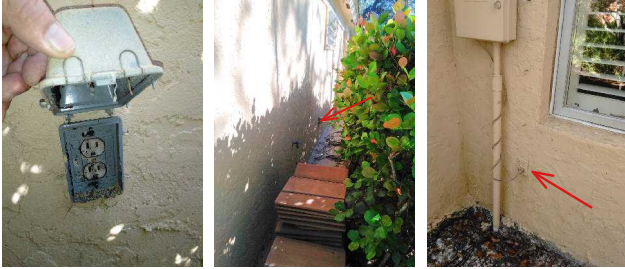
4. Exterior Electric Outlets: **110 VAC** - **Inoperative at time of inspection, Outlets have visible corrosion, Loose or missing moisture cover**

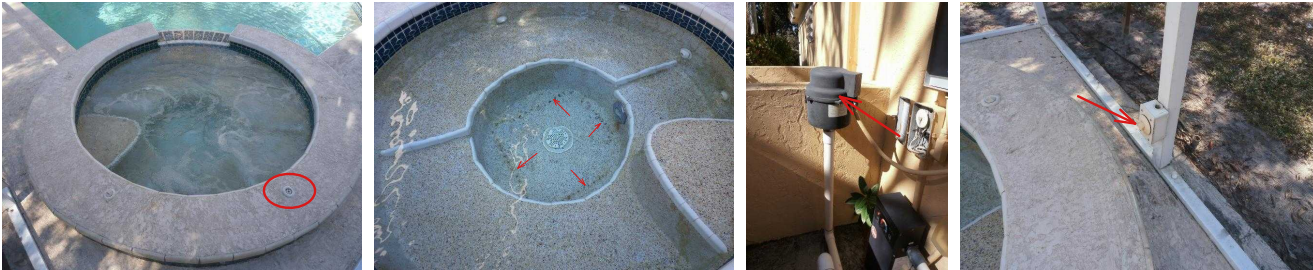
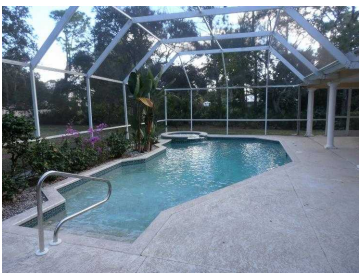
5. Behind home Swimming Pool Type: **In ground with spa** - **Blower for spa jets does not work, pump air jet adjustment cap on spa deck is missing. Appears that individual pump timers for spa and pool are tied into one main timer. Did not locate child safety screens for pool deck protection. Check with current owner if possible. A licensed pool company is recommended to go through and evaluate complete system and specify what all needs repaired for proper operation**

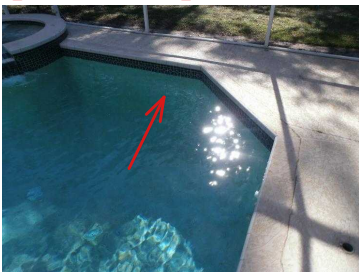
6. Behind home Swimming Pool Pool Light **Submersed** - **Pool and spa light did not come with switch, Water/rust stains noted at bottom of pool light. Further evaluation by a qualified pool tech is recommended**

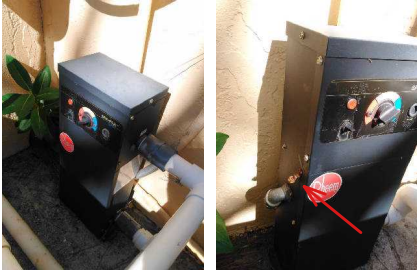
7. Behind home Swimming Pool Heater: **Rheem** - **Not properly grounded, missing ground wire, Would not function, power light came on but did not appear to be heating. Further evaluation by a licensed pool tech is recommended.**

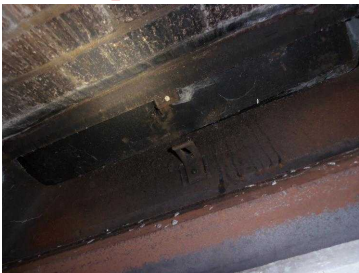
8. Family Room Fireplace Damper: **Metal** - Damper latch is missing or broken, cannot secure damper in closed position to prevent conditioned air in home from escaping through chimney flue when not in use

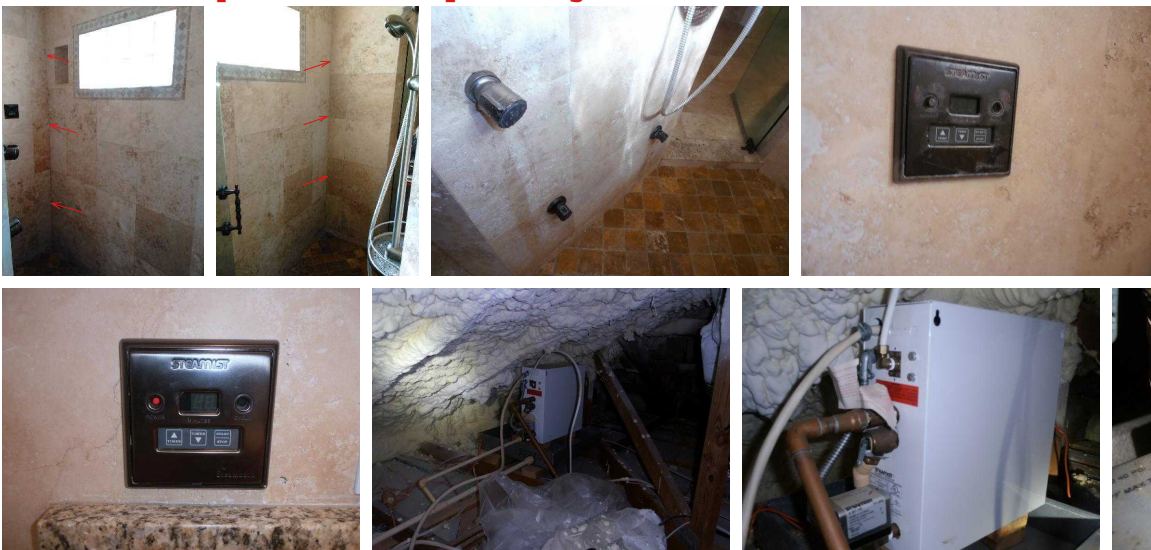
9. Master Bathroom Shower/Surround: **Tile pan and tile surround** - Cracked grout in corners of shower surround, this is typical of cement based grout being used for corner applications due to expansion and contraction. Recommend replacing with grout "caulk" to help prevent moisture intrusion. Grout caulk can be located in the tile section at most hardware stores, Steamer for shower was not in use at time of inspection. Note on main electrical panel to leave steamer breaker in OFF position. Steam unit is located in attic. Touch control pad in bathroom shower shows signs of corrosion. Further evaluation by a licensed plumbing contractor is recommended.

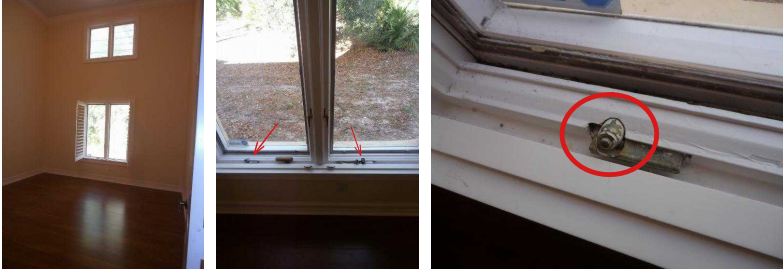
10. Left front guest Bedroom Windows: **Wood casement - Will not open-requires correction, window crank is broken**
