eyezon Home Inspectors
470 Golden Gate Blvd. W.
Naples, FL 34120

Real Estate Inspection Report

12345 Sample Street
Marco Island, FL 55555

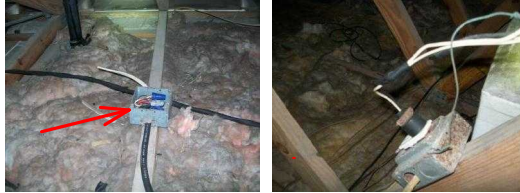
Wiring/Lighting: 110 VAC ----- Open junction boxes, All open junction boxes need covers, improper electrical plug noted, Evaluation by a licensed electrician is recommended

7. **Hallway Attic Insulation Depth:** 3" ----- Insulation compressed, Recommend additional insulation be installed
8. **Hallway Attic Wiring/Lighting:** 110 VAC ----- Open junction boxes, All open junction boxes need covers, improper electrical plug noted, Evaluation by a licensed electrician is recommended

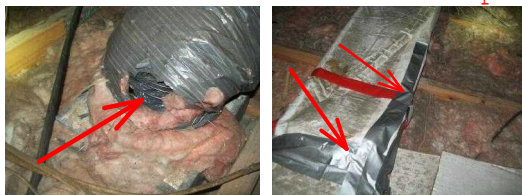
Exposed Ductwork: Insulated stack ----- Open (loose) flex duct to back room and damaged trunk line that they tried to fix with duct tape is leaking cold air into attic, A qualified contractor is recommended to evaluate and estimate repairs

4. **Exposed Ductwork: Insulated stack** ----- Open (loose) flex duct to back room and damaged trunk line that they tried to fix with duct tape is leaking cold air into attic, A qualified contractor is recommended to evaluate and estimate repairs

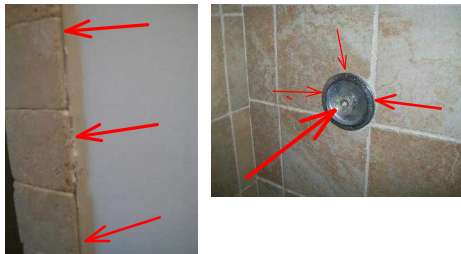
Acceptable	Sink/Basin: Molded single bowl
Acceptable	Faucets/Traps: Functioning
Marginal	Shower/Surround: Ceramic tile pan and walls ----- Loose / missing grout, Water control very hard to operate which is common on older fixtures that have not been used in a while, repair may be necessary if it continues to be stiff, also trim ring needs secured

- 9. Master Bathroom Shower/Surround:** Ceramic tile pan and walls ----- Loose / missing grout, Water control very hard to operate which is common on older fixtures that have not been used in a while, repair may be necessary if it continues to be stiff, also trim ring needs secured

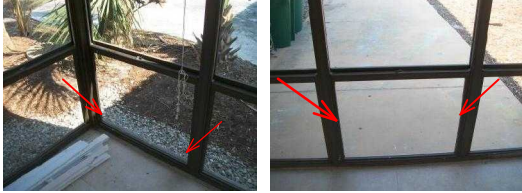
- 14. Living Room and entrance, Dining Room, Lanai Living Space Windows:** Aluminum crank
----- Window sticks-improve operation at front, Repair or replace window
balancer's on back lanai (2 windows) = safety issue

Acceptable	Closet: Single
Acceptable	Ceiling: Paint
Acceptable	Walls: Paint
Acceptable	Floor: Tile
Acceptable	Doors: Hollow wood
Marginal	Windows: Aluminum crank ----- Window sticks-improve operation at front, Repair or replace window balancer's on back lanai (2 windows) = safety issue

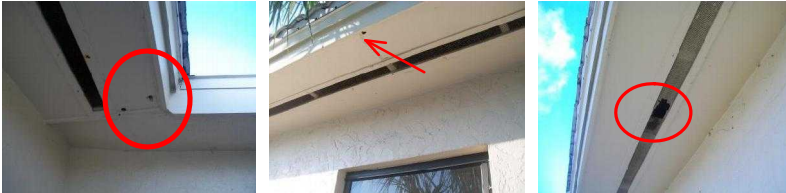
1. **Soffits: Wood** ----- Damaged screen, Wood rot, A qualified repair person is recommended to evaluate and repair all exterior areas

Soffits: Wood ----- Damaged screen, Wood rot, A qualified repair person is recommended to evaluate and repair all exterior areas

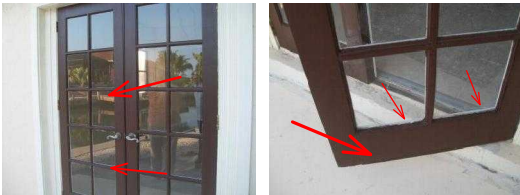
3. **Patio Door: Metal with glass, French door** ----- Left side of french door won't open and has wood rot at bottom and around window glass, A qualified contractor is recommended to evaluate and estimate repairs

Patio Door: Metal with glass, French door ----- Left side of french door won't open and has wood rot at bottom and around window glass, A qualified contractor is recommended to evaluate and estimate repairs
