THE NORFOLK RIVERS TRUST
RESTORING NORFOLK'S RIVERS

THE RIVER NAR

A WATER FRAMEWORK DIRECTIVE LOCAL CATCHMENT PLAN

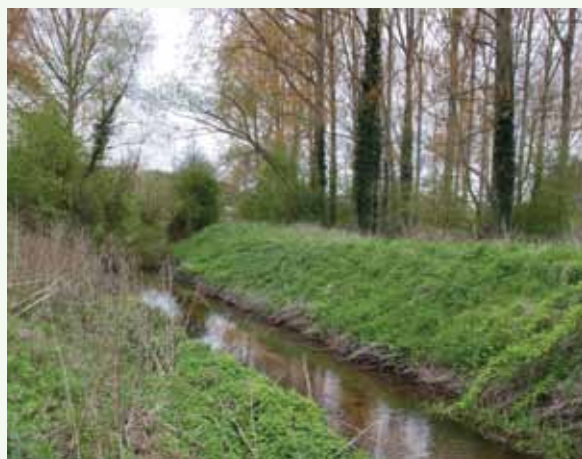
CANALISATION and DREDGING creates a river that is isolated from its riparian fringes and floodplain: a low-energy, spring-fed stream flowing through an incised trench is unable to function as a river and the whole river's ecology suffers.

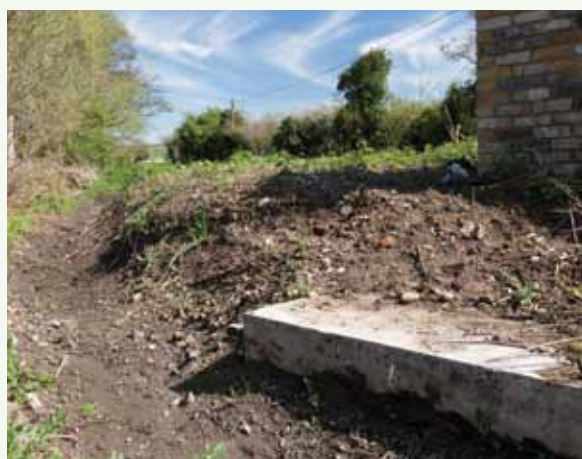
SEDIMENT POLLUTION which washes off farmland, hard-stands, tracks and roadside verges flows into the river through a network of drains and ditches.

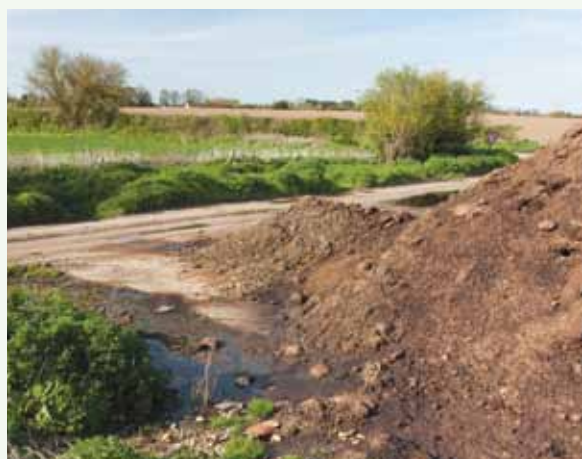
POOR AGRICULTURAL PRACTICES. This pile of manure was left on a hard-standing beside the river (April 2012) and its effluent was leaching across the road, into a ditch, through a culvert and into the river.

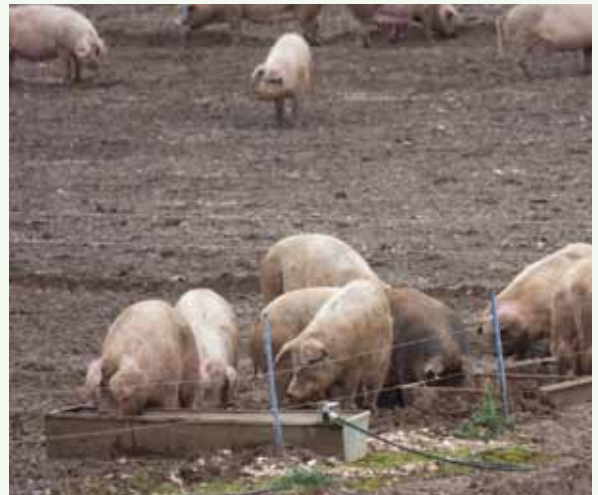
PIG-FARMING is an increasing presence in the valley. Unchecked the run-off from pig fields can be massive and it arrives at the river along roads and tracks and ditches.

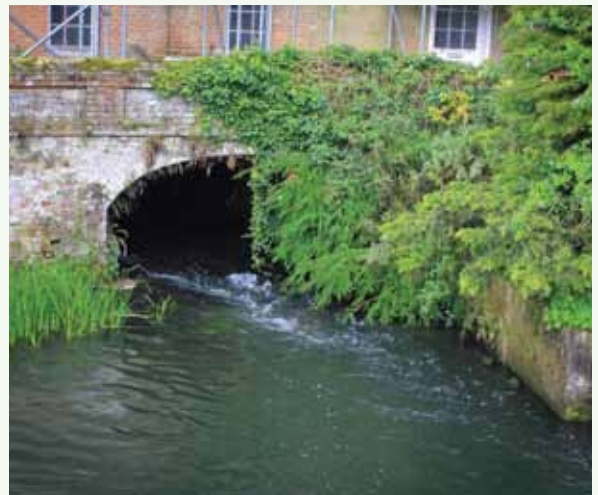
IMPOUNDMENTS are a major impediment to the ecological well being of the river: not only do they cause an accumulation of sediment in the impounded reaches, but they also impede the free passage of fish.

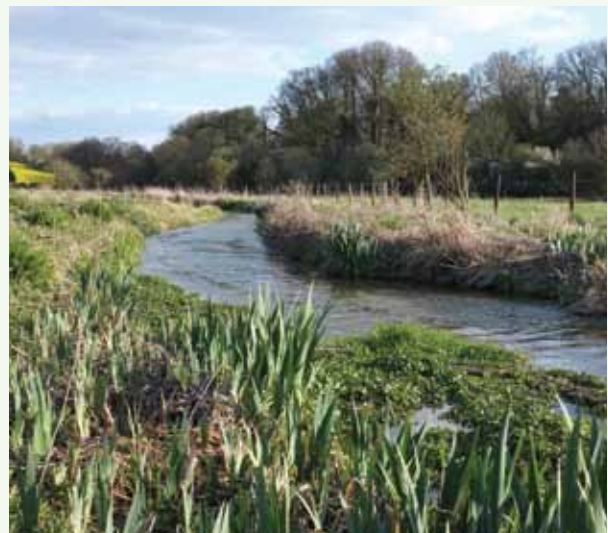
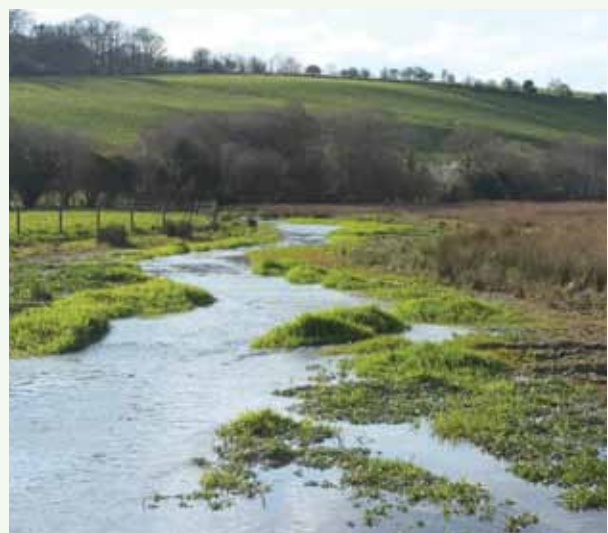
On an undredged reach of the Sydling Brook in Dorset (above and below) it is possible to see the interaction between a diverse community of plants in a shallow wetted, riparian margin and the dynamic, sinuous channel. Note these picture were taken in low flows and yet the river is close to bank level.

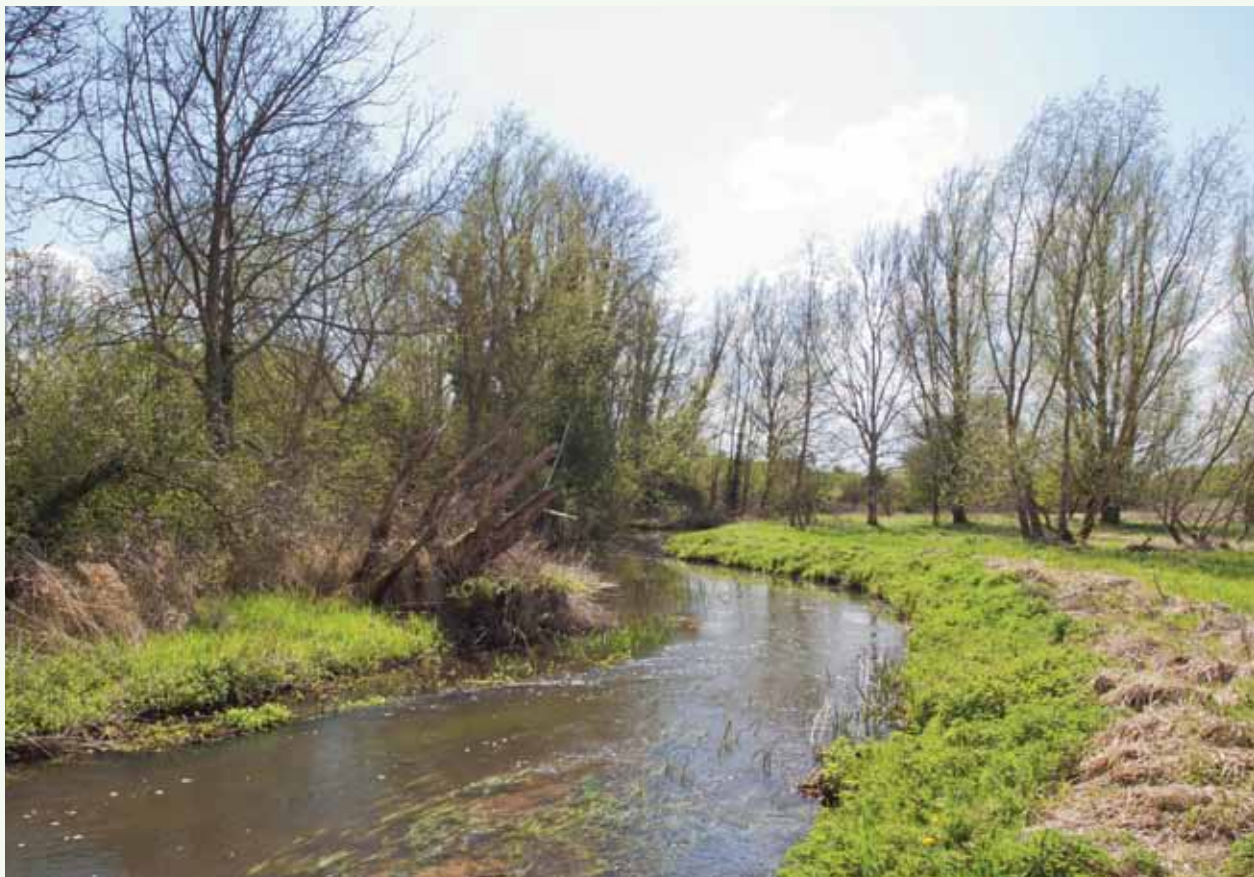
Connectivity is the underlying issue on the upper Nar. This reach (above) just outside Castle Acre is a good example of a part of the river that looks unmodified but which has, in fact, been dredged: the northern (right) bank is a levee formed by dredgings from the river. And again below the northern (left) bank is built high by dredgings. Even in flood – as illustrated in both photos – the channel is so incised that water is nowhere near the top of the bank.

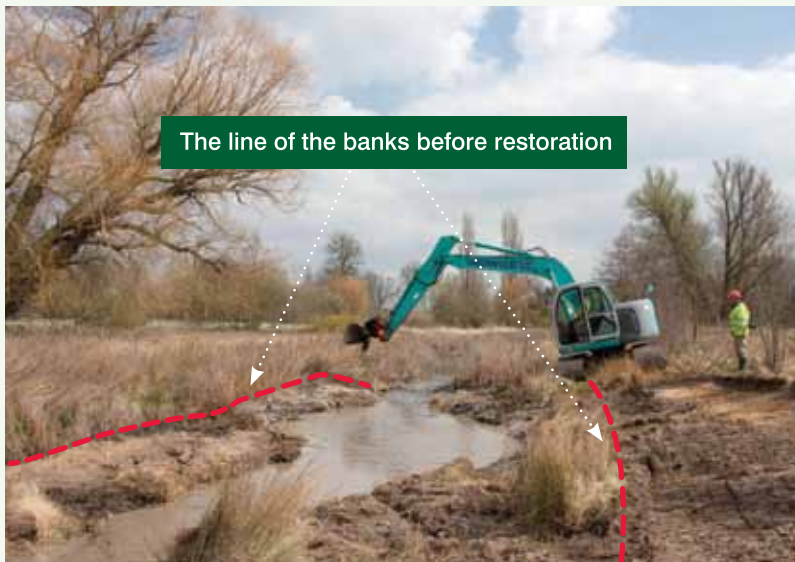
The line of the banks before restoration

The front edge of the new bank is planted up with plugs of reed canary grass. When the river rises in higher flows it will be able to spill over the margins and deposit silt on the bank edges and in the back eddies created by the uneven planform, while the main channel remains scoured and clean.

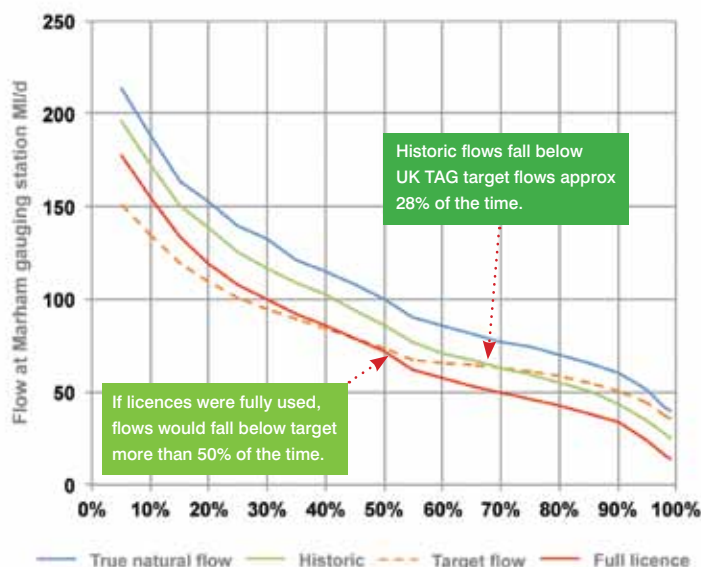
ABSTRACTION GRAPH 3 UPSTREAM OF NARBOROUGH

ABSTRACTION GRAPH 4 DOWNSTREAM OF NARBOROUGH

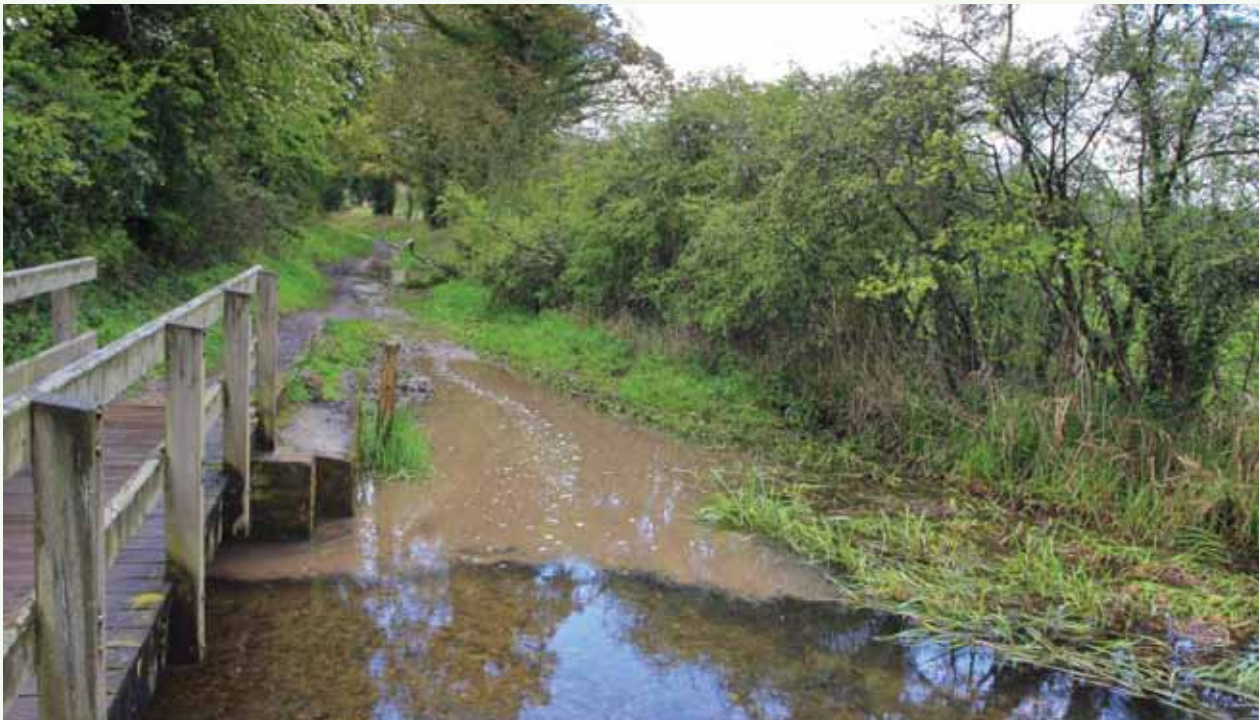
West Acre ford after a heavy downpour May 2012: a clear illustration of the impact of point-source sediment pollution. Diverting this flow into a wetland settlement pond in the meadow beside the river would make a big difference with the add-on ecological benefit of creating more wetland habitat.
